# Tri State Home Inspections

## Home Inspection Report

**559**

**Valley Forge Ln**

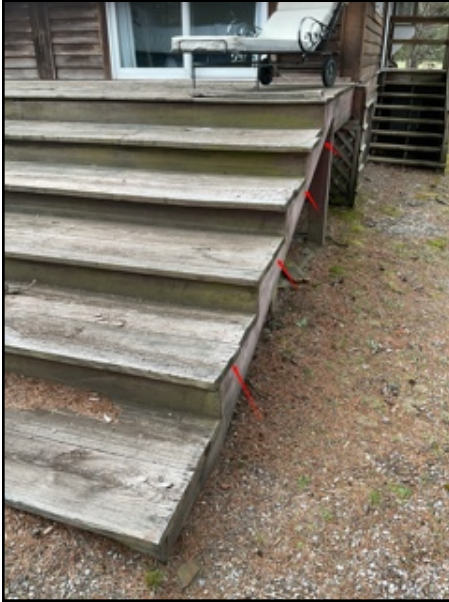
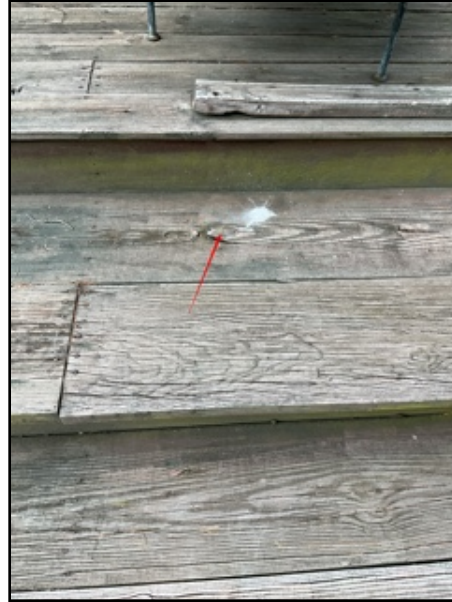
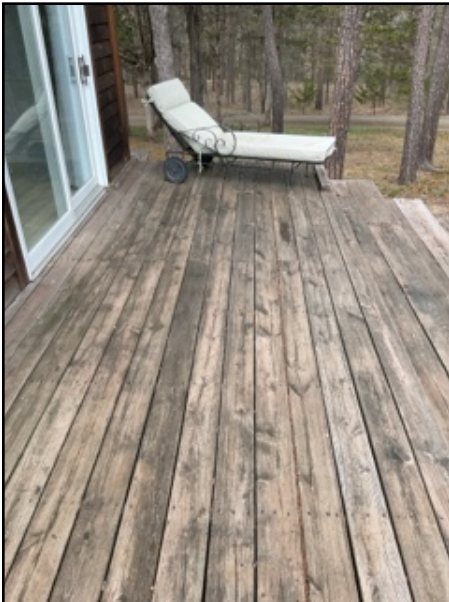
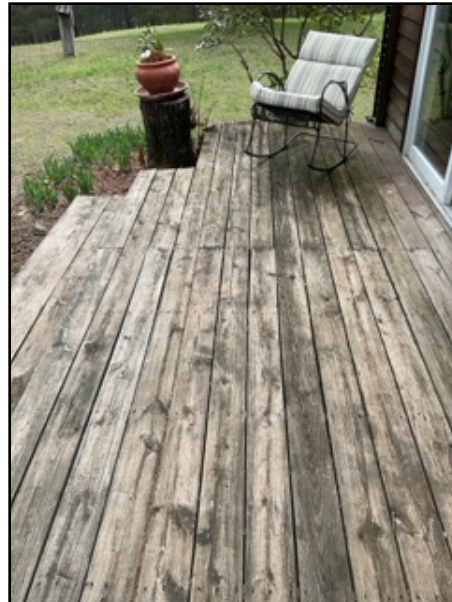
Some of the steps are in poor condition and some of the deck boards are coming loose recommend repair .

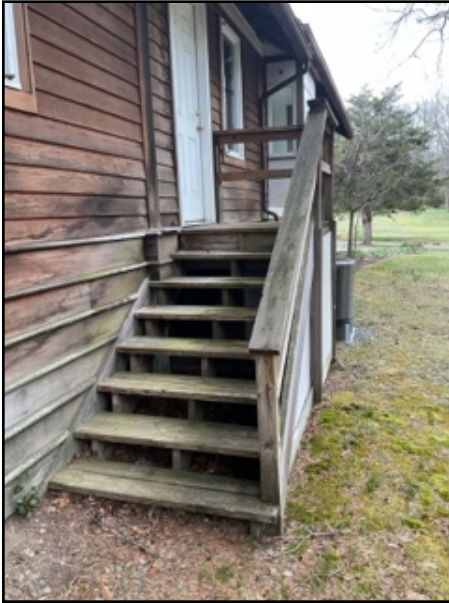
Figure 2-1

Comment 2:  
Some of the steps are coming loose recommend repair .

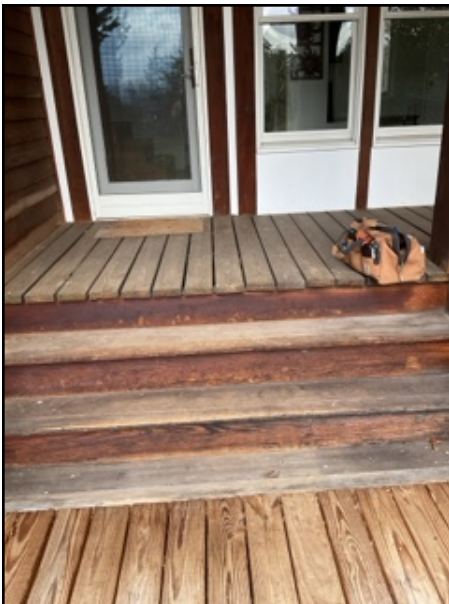
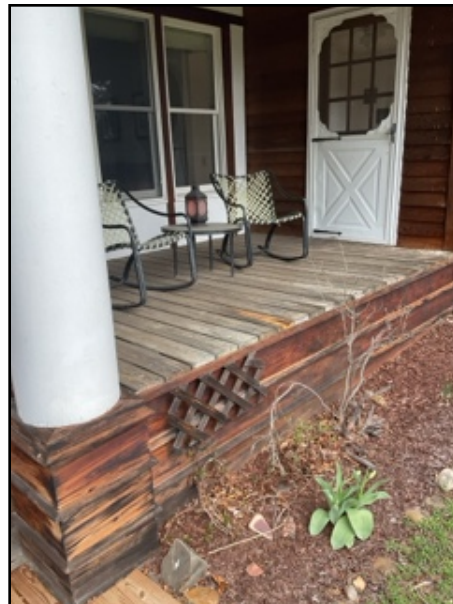
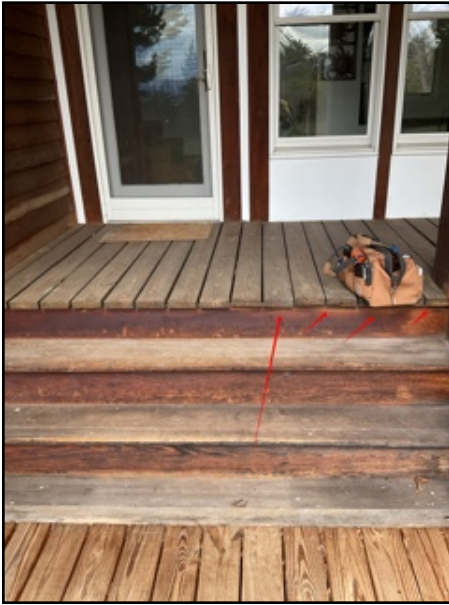
Comment 3:  
Some of the front porch deck boards are coming loose recommend repair .

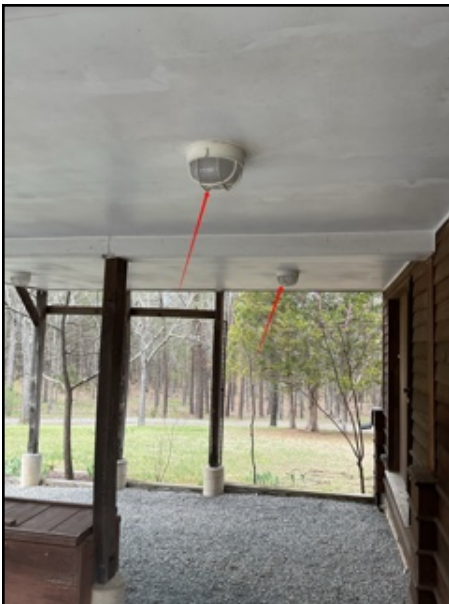
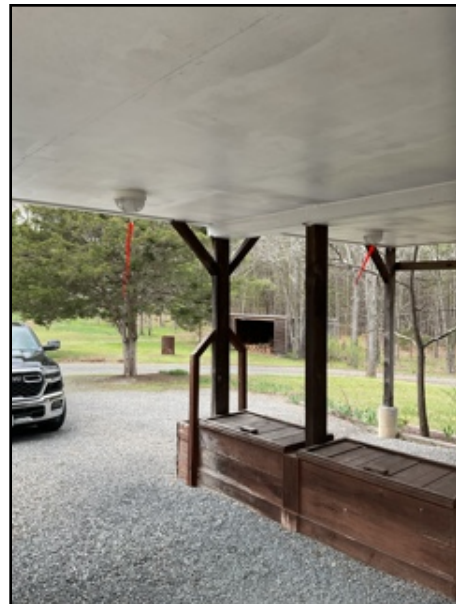
Unable to get the carport lights to work recommend repair or replace .

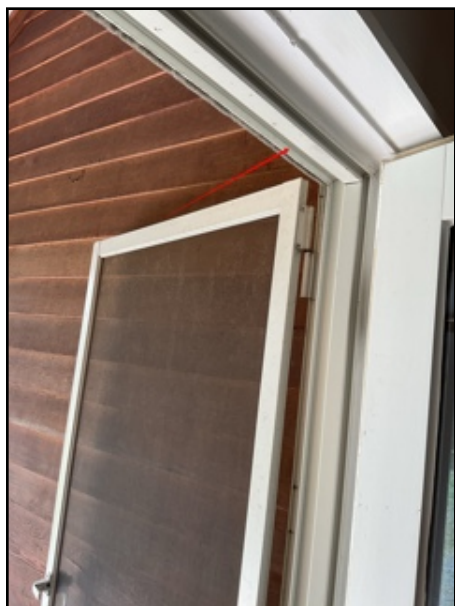
Figure 6-1

Recommend installing a stabilizer on the front screen door for safety reasons .

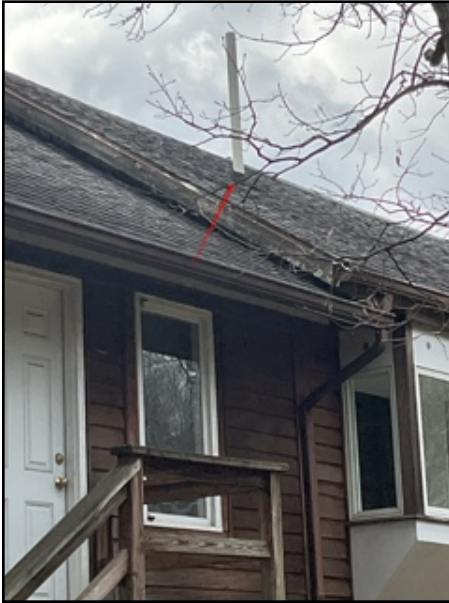
Figure 8-1

The rear rubber boot vent stack seal is in poor condition recommend replacing .

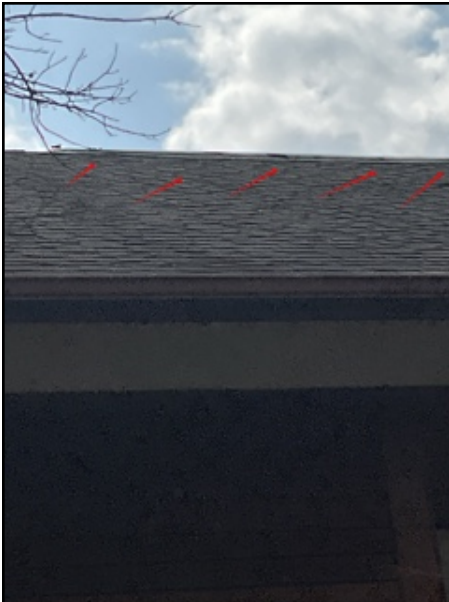
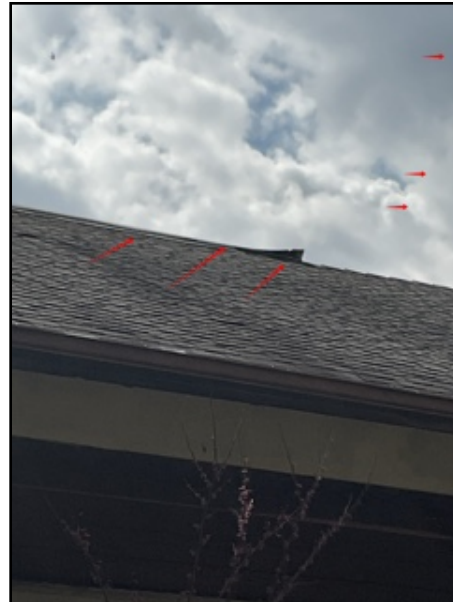
The metal ridge cap section is in very poor condition recommend replacing to prevent damage from occurring .

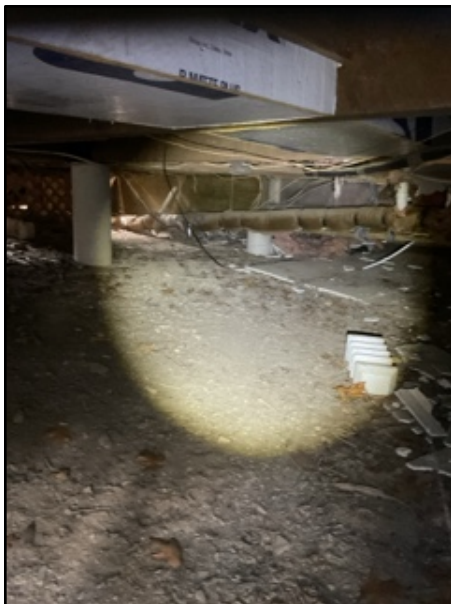
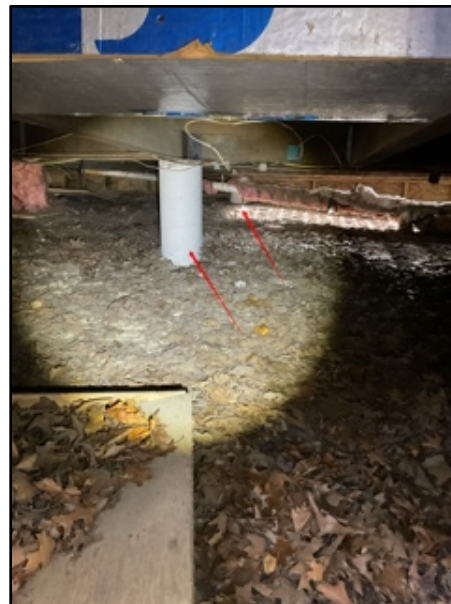
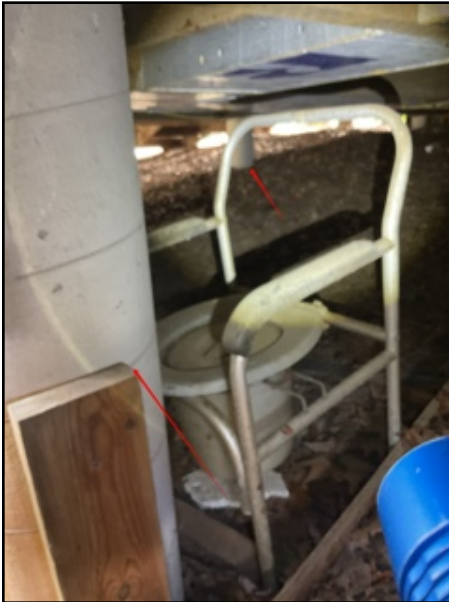
The concrete piers appear to be in satisfactory condition if there is any doubt recommend further evaluation by a licensed contractor for further assessment .

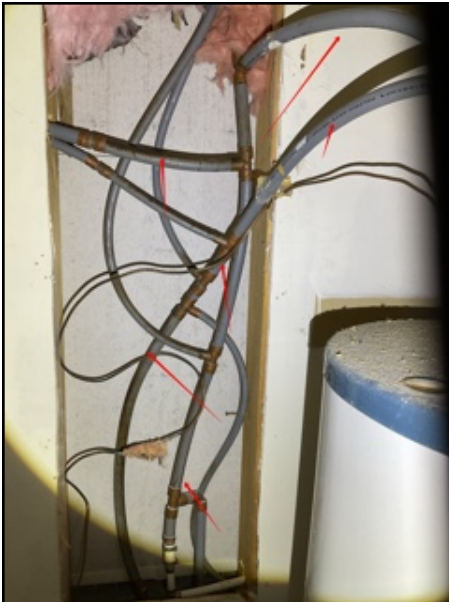
Figure 16-1

The water supply lines are polybutylene recommend further evaluation y a licensed plumber for further assessment .

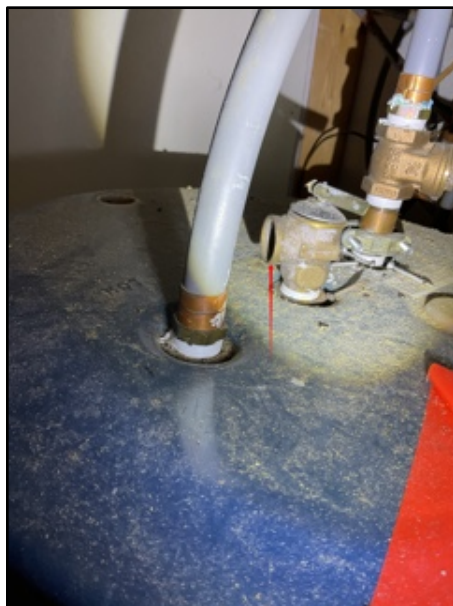
Figure 17-1

Recommend installing a blow off leg for safety reasons .

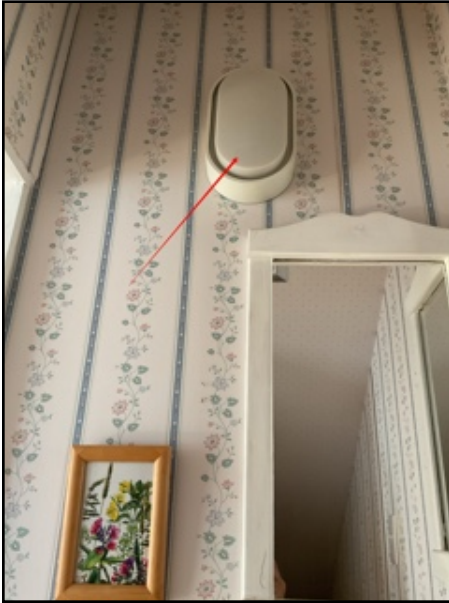
Figure 18-1

Unable to get the light to work recommend repair or replace .

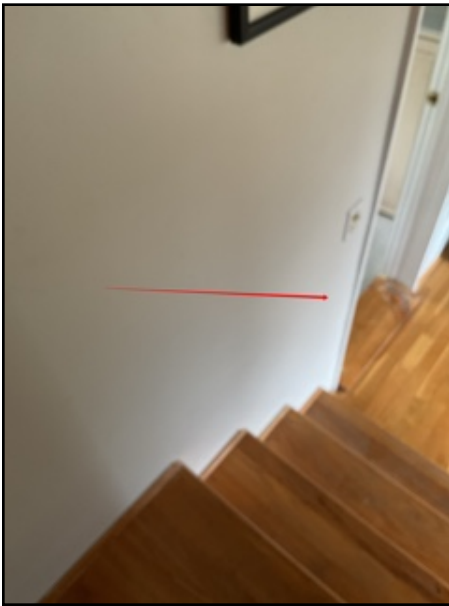
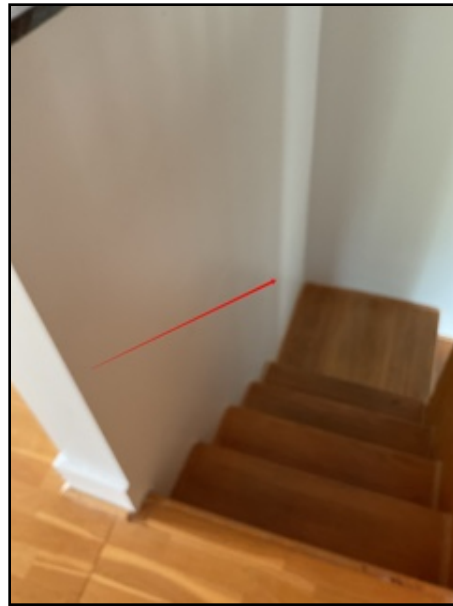
Recommend installing some hand rails for safety reasons .

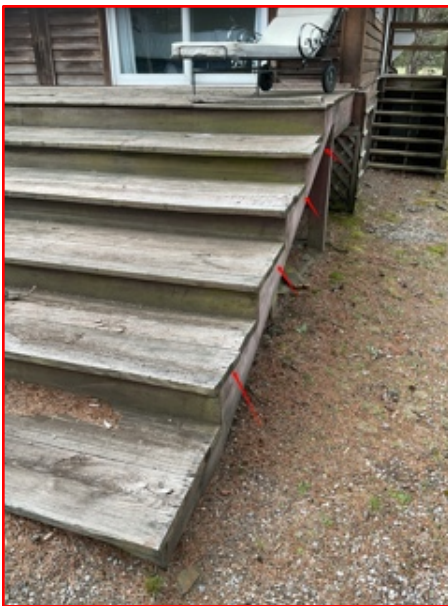
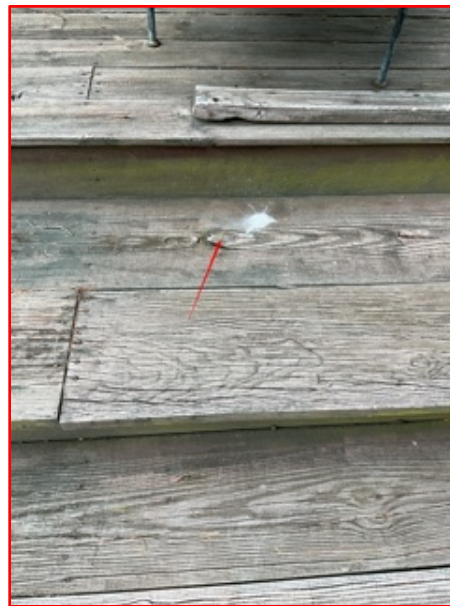
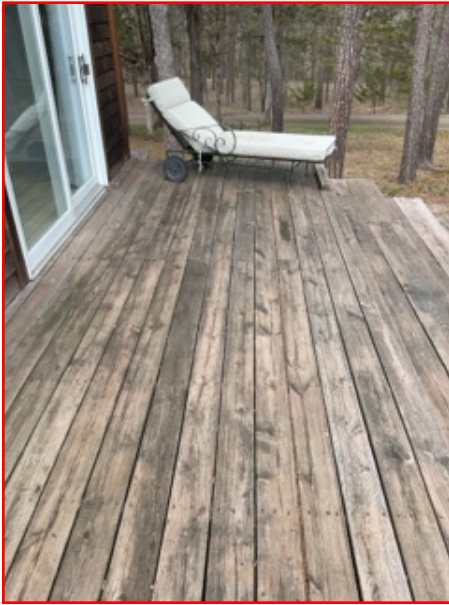
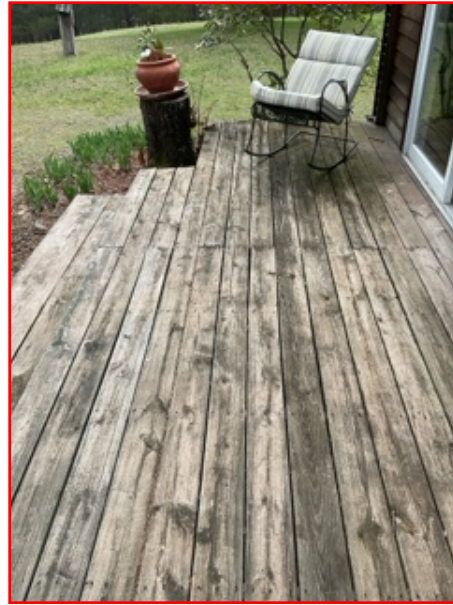
1) Some of the steps are in poor condition and some of the deck boards are coming loose recommend repair .

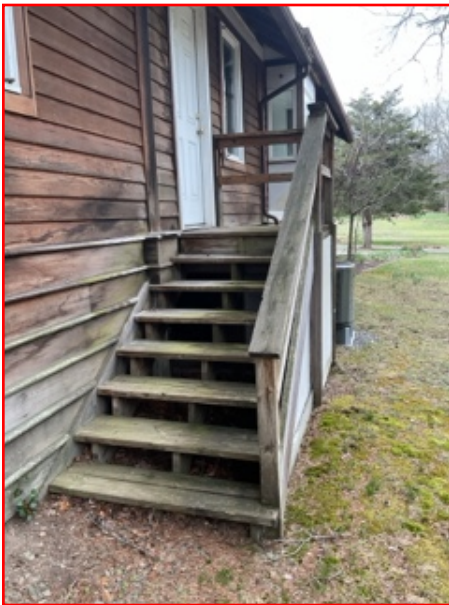
Figure 2-1

2) Some of the steps are coming loose recommend repair .

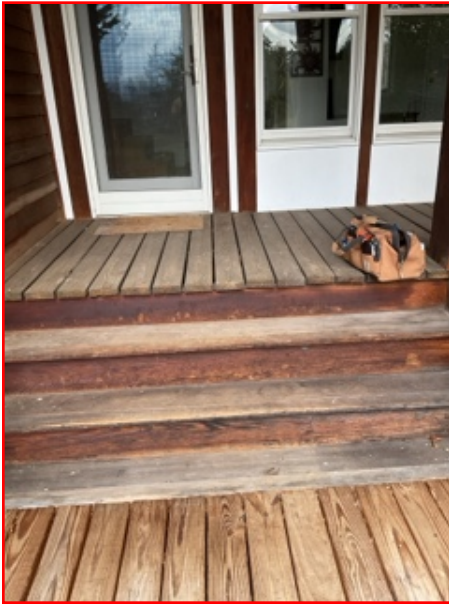
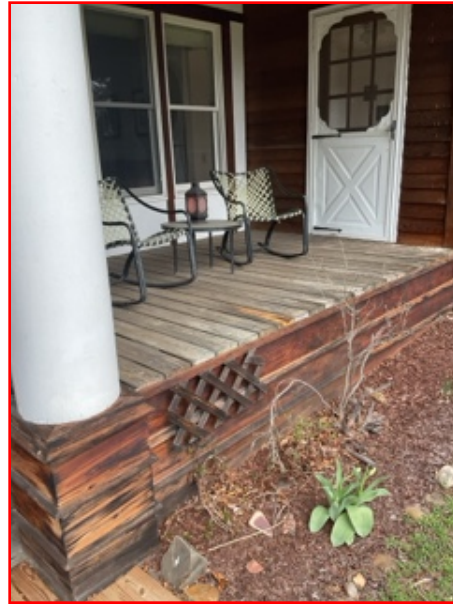
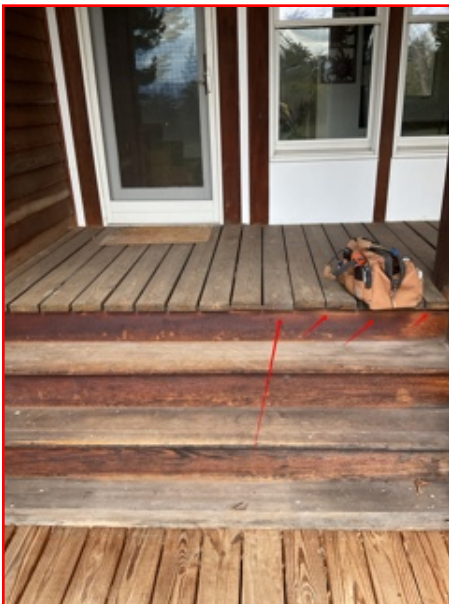
3) Some of the front porch deck boards are coming loose recommend repair .

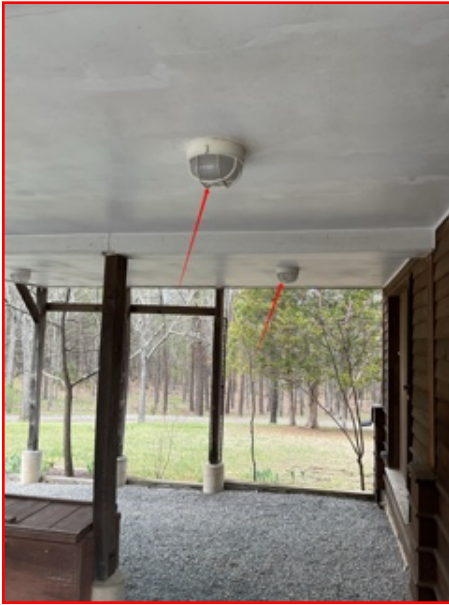
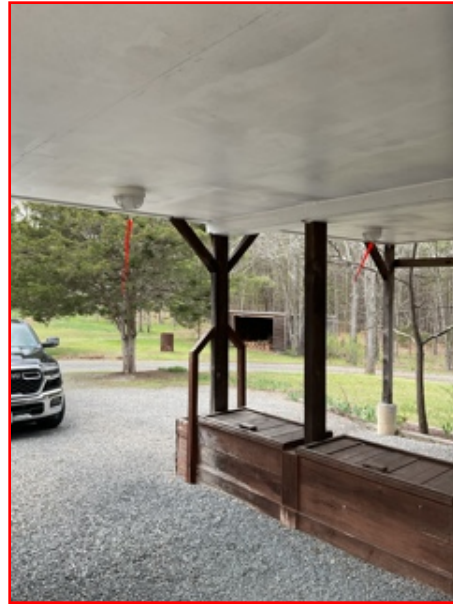
4) Unable to get the carport lights to work recommend repair or replace .

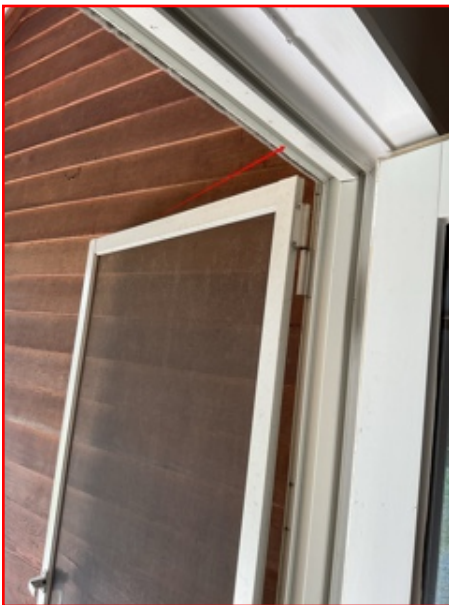
Figure 6-1

5) Recommend installing a stabilizer on the front screen door for safety reasons .

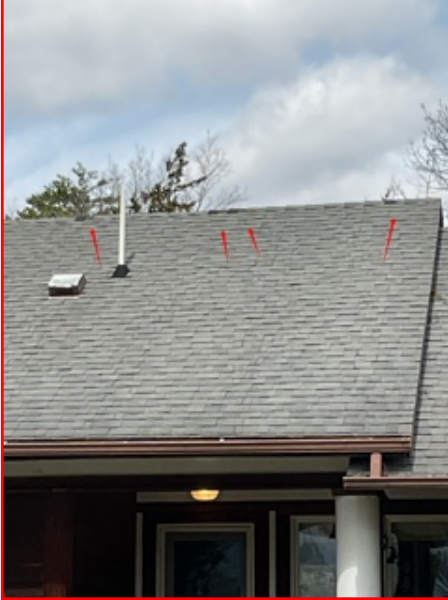
Figure 7-1

6) Some of the ridge cap shingles are missing recommend having them replaced to prevent damage from occurring .

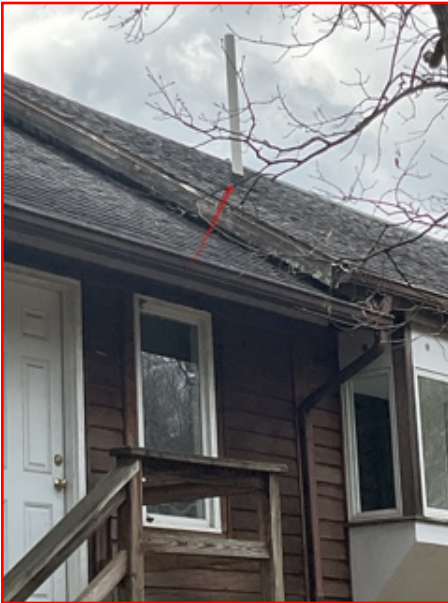
Figure 8-1

7) The rear rubber boot vent stack seal is in poor condition recommend replacing .

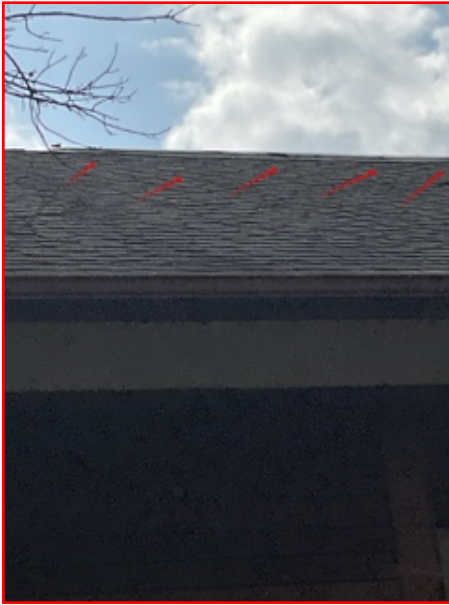
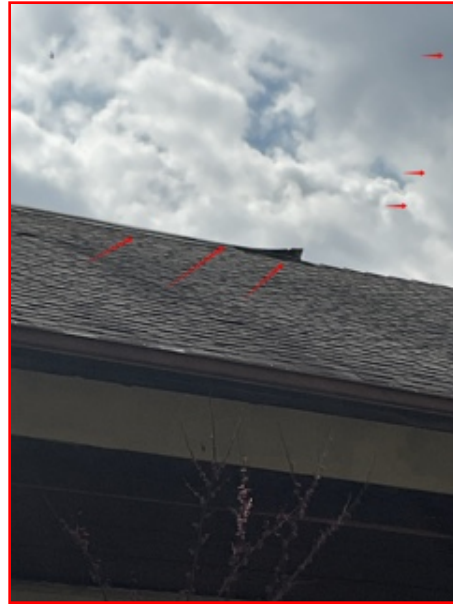
8) The metal ridge cap section is in very poor condition recommend replacing to prevent damage from occurring .

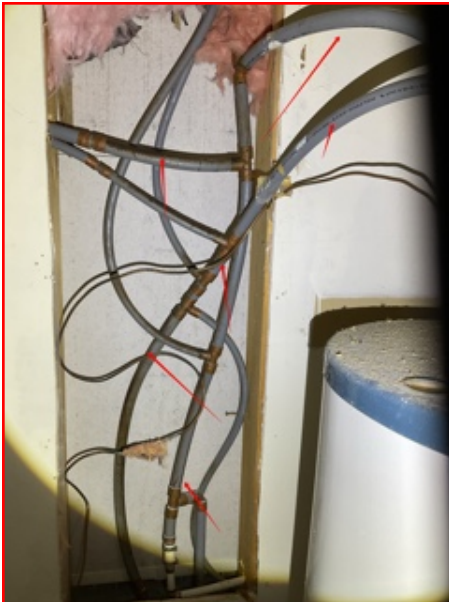
Figure 16-1

10) The water supply lines are polybutylene recommend further evaluation y a licensed plumber for further assessment .

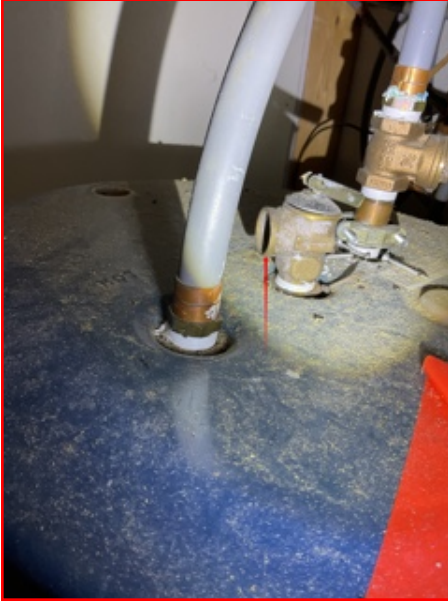
Figure 17-1

11) Recommend installing a blow off leg for safety reasons .

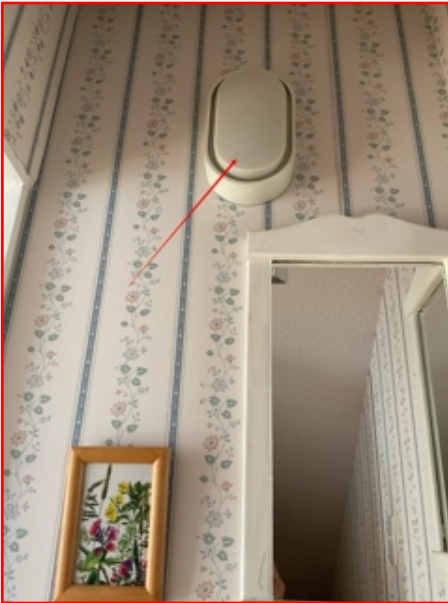
Figure 18-1

12) Unable to get the light to work recommend repair or replace .

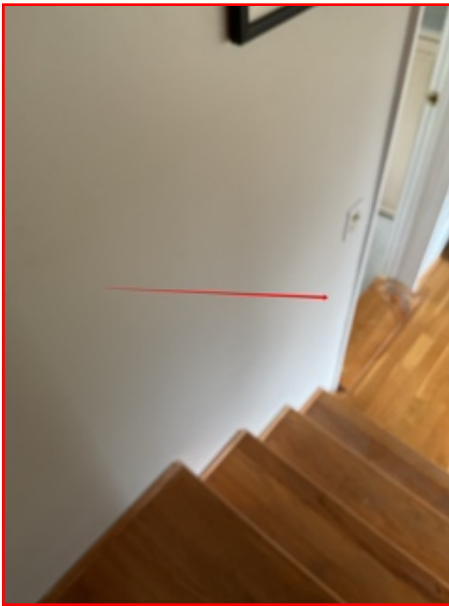
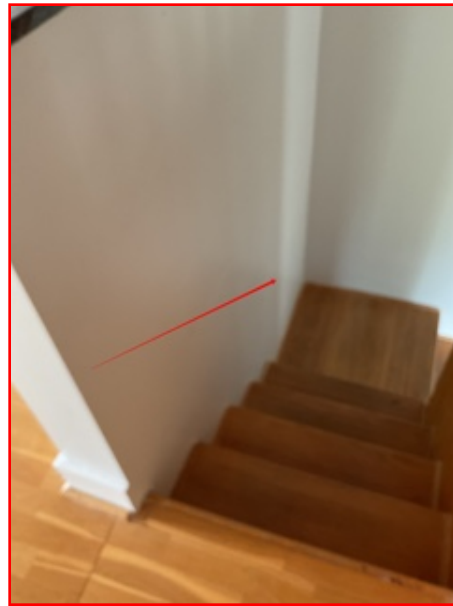
13) Recommend installing some hand rails for safety reasons .
