# Tri State Home Inspections

## Home Inspection Report

**563**

**Valley Forge Ln**

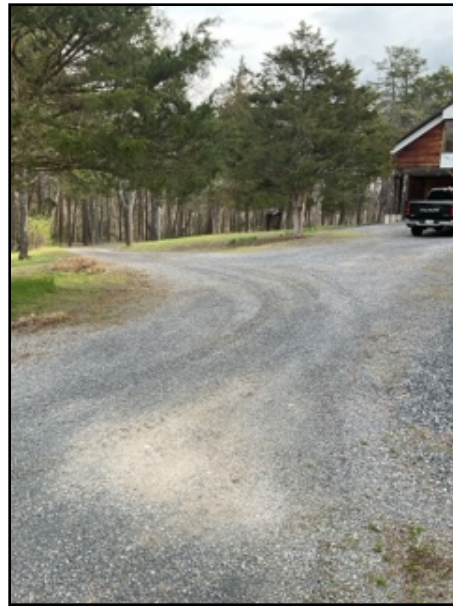
Figure 1-1

Comment 1:  
The driveway is satisfactory .

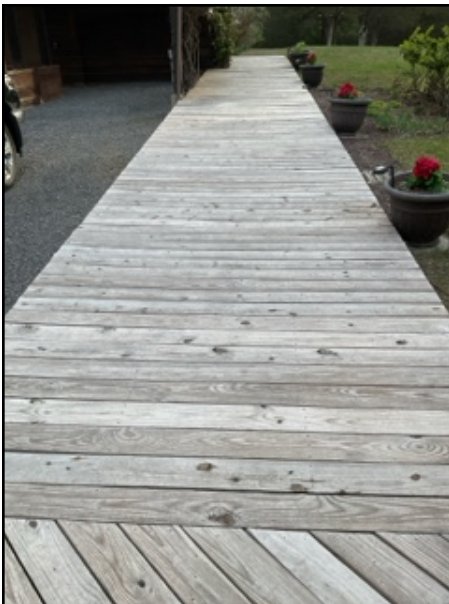
Figure 2-1

Comment 2:  
Some of the boards on the wood walkway are coming loose recommend repair as needed .

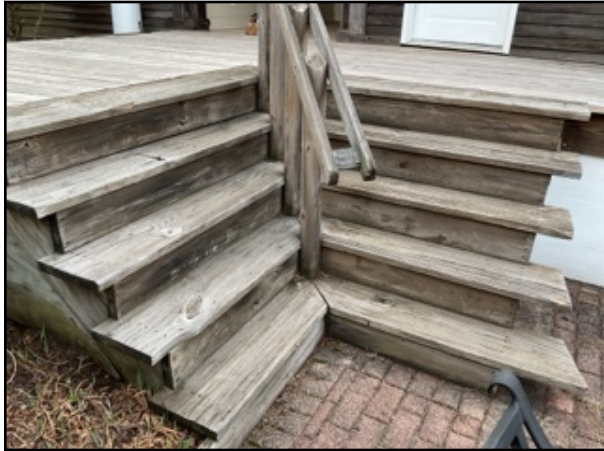
Figure 3-1

Some of the steps are coming loose and are in marginal condition recommend repair for safety reasons .

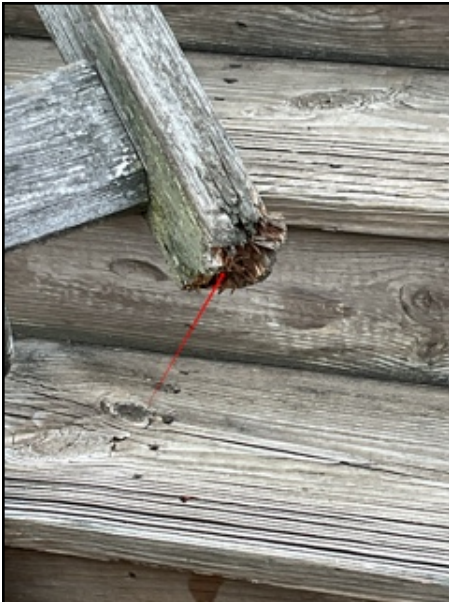
Figure 4-1

The hand rail is in poor condition recommend repair or replace .

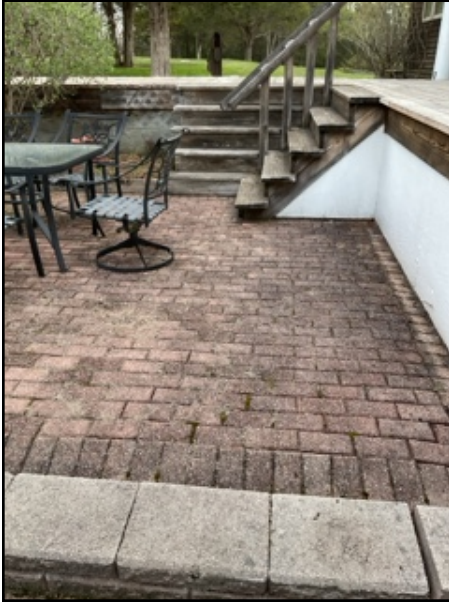
Figure 5-1

The patio has settled in different places causing loose pavers and tripping hazards recommend repair .

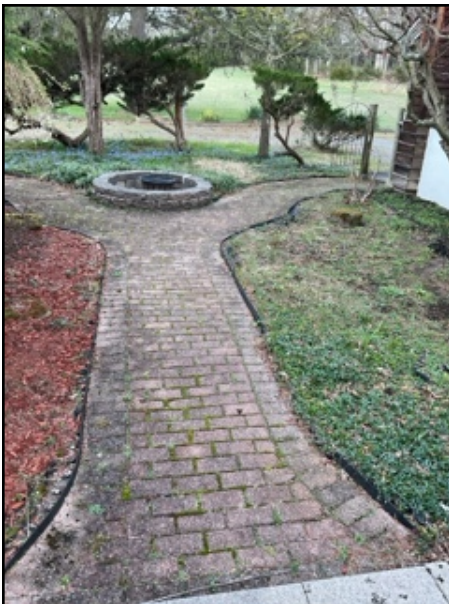
Figure 6-1

The paver walkway has a tripping hazard in it recommend repair .

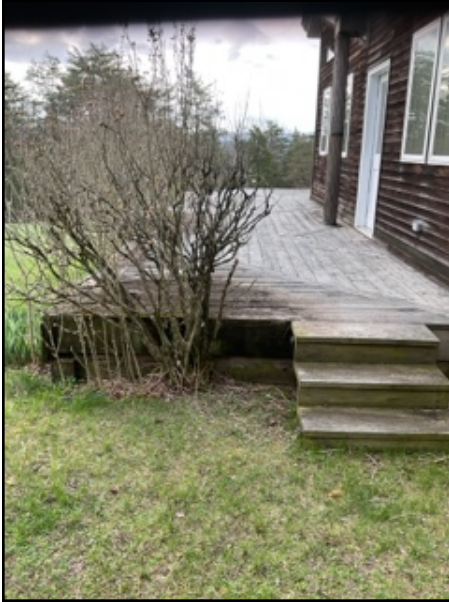
Figure 9-1

The deck has some sections that are in poor condition and some that are in marginal condition recommend repair and replace as needed for safety reasons .

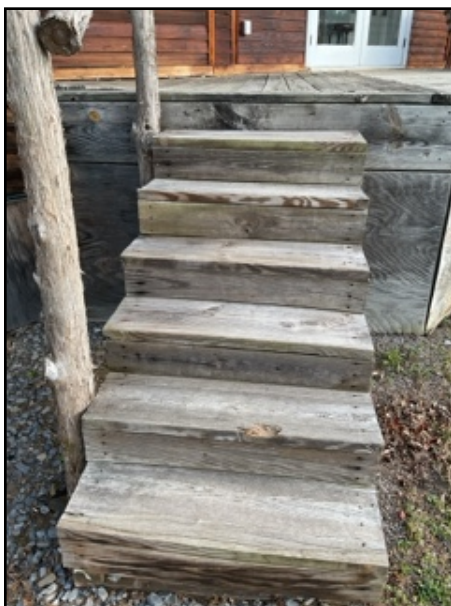
Figure 10-1

**Comment 10:**  
Several of the deck steps are loose recommend repair for safety reasons .

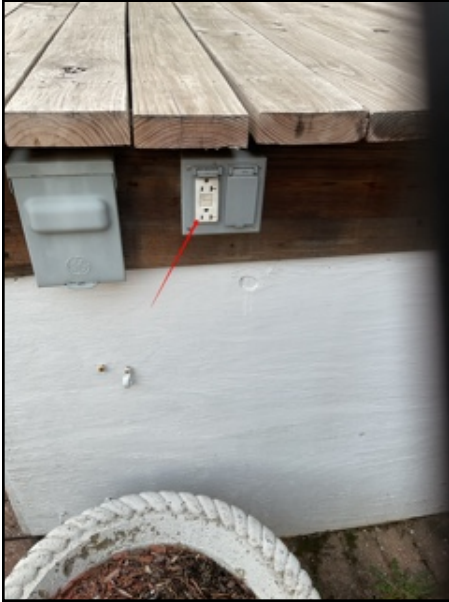
Figure 11-1

The front exterior receptacle attached to the porch has no power recommend repair .

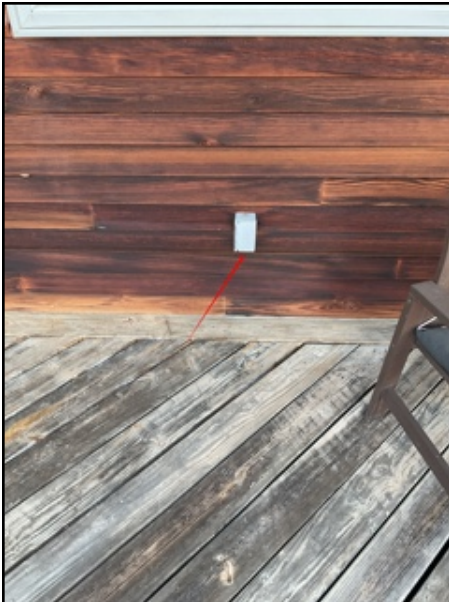
Figure 12-1

The left rear receptacle has no power recommend repair .

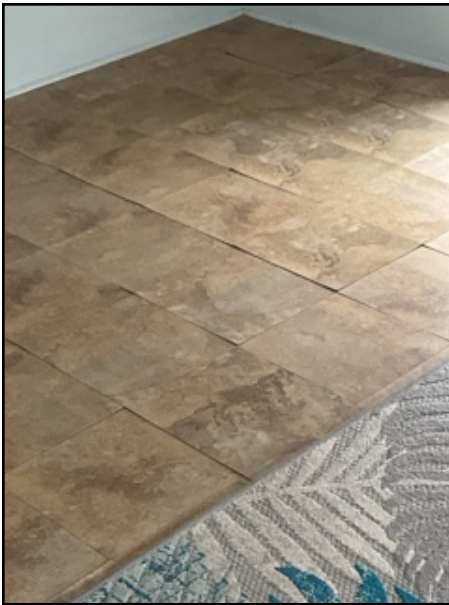
Figure 20-1

The vinyl flooring in the garage apartment is in poor condition recommend replacing .

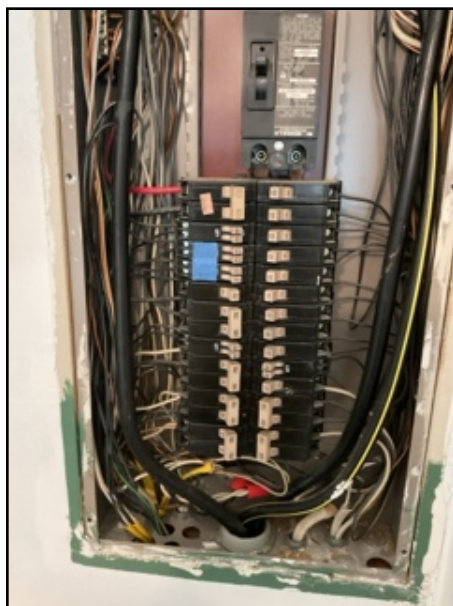
Figure 25-1

Comment 25:  
The garage service panel is satisfactory .

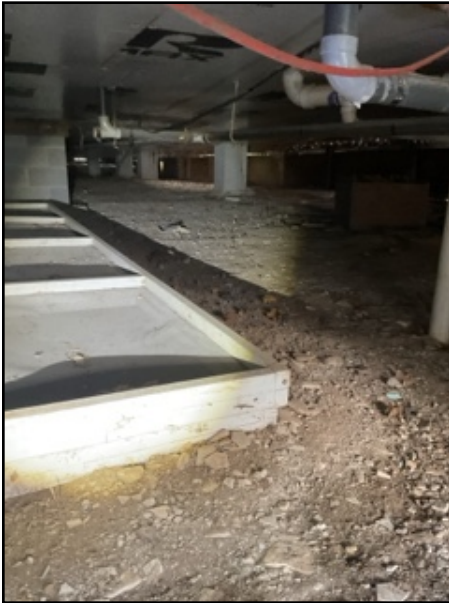
Figure 27-1

The foundation piers appear to be in satisfactory condition if there is any doubt recommend having them evaluated by a licensed contractor for further assessment

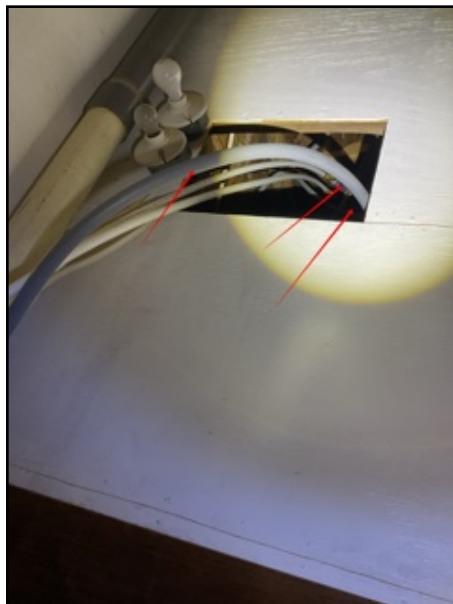
Figure 34-1

Some of the water supply lines are polybutylene recommend further evaluation by a licensed plumber for further assessment .

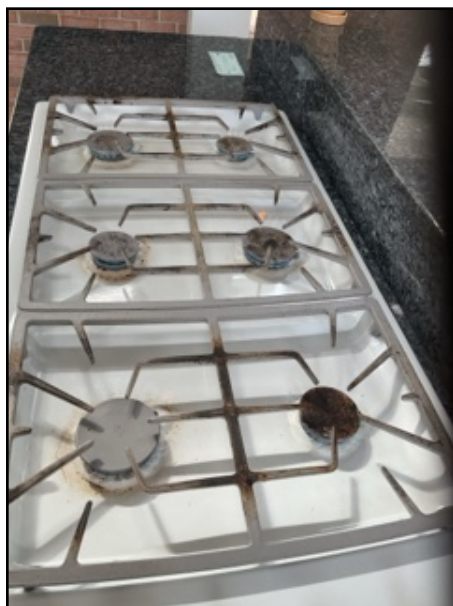
Figure 39-1

Comment 39:  
The cooktop is satisfactory .

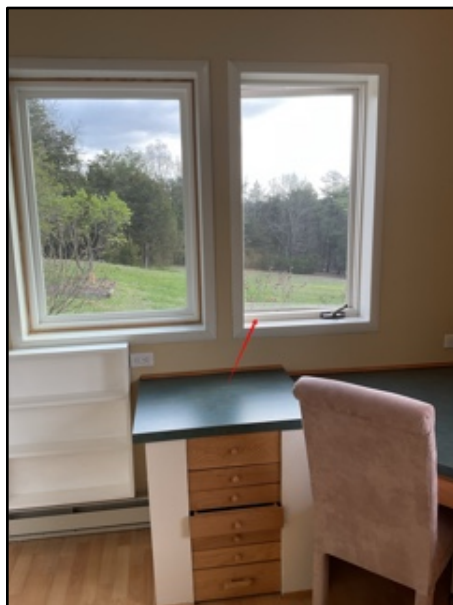
Figure 40-1

**Comment 40:**  
The left side window in the left side bedroom has come loose from its trac recommend repair .
