# Tri State Home Inspections

## Home Inspection Report

**563**

**Valley Forge Ln**

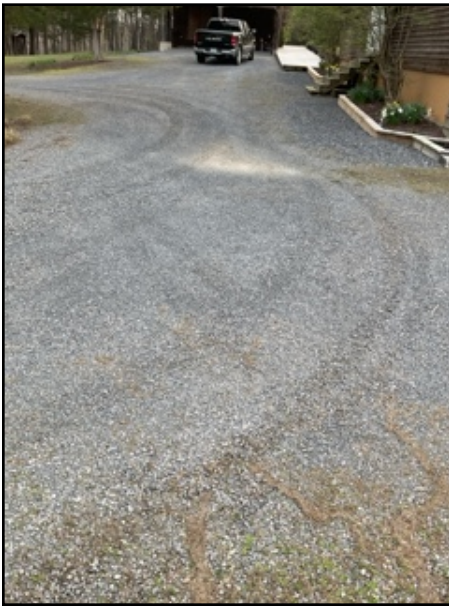
Figure 1-1

Comment 1:  
The driveway is satisfactory .

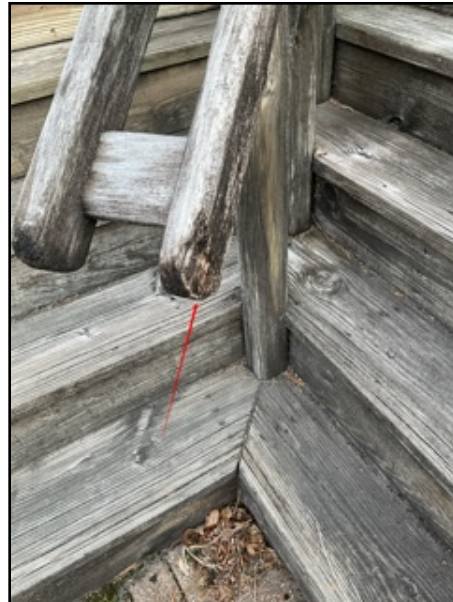
Figure 4-2

The hand rail is in poor condition recommend repair or replace .

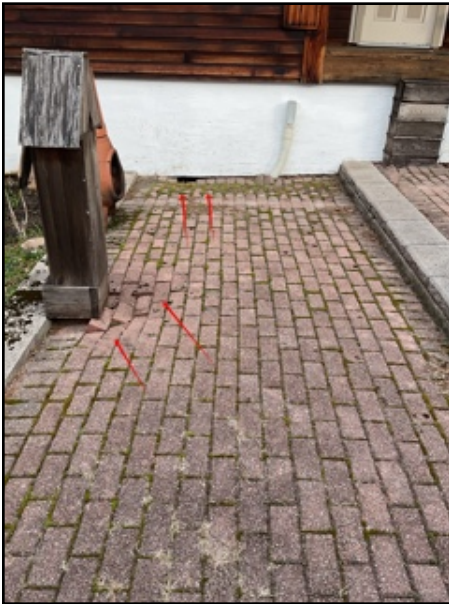
Figure 5-3

The patio has settled in different places causing loose pavers and tripping hazards recommend repair .

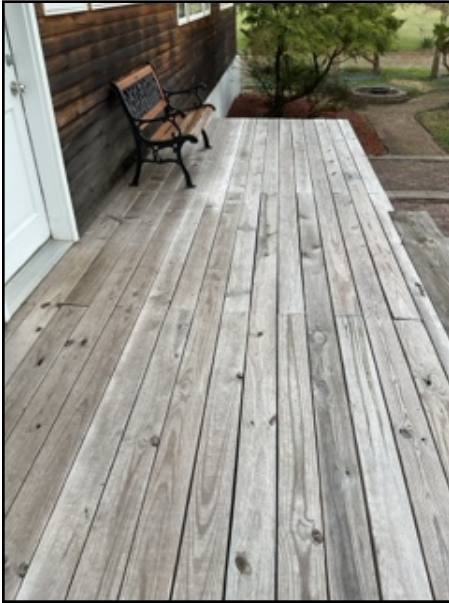
Figure 7-1

Comment 7:  
The front porch is satisfactory .

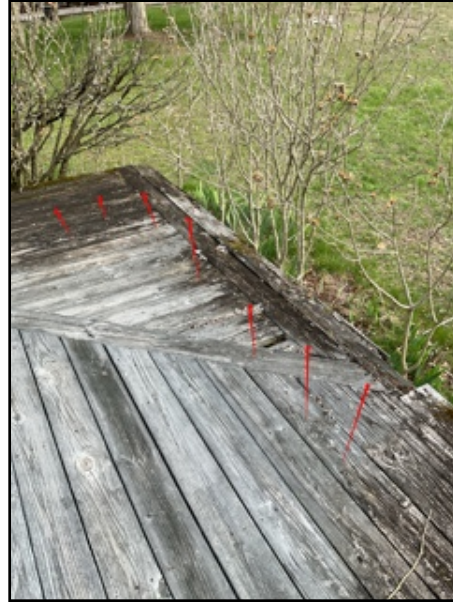
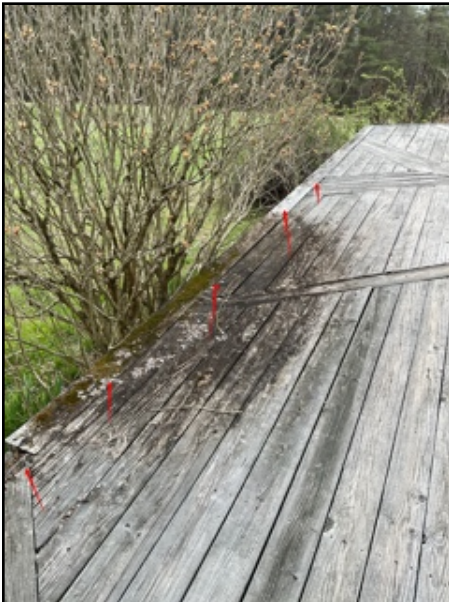
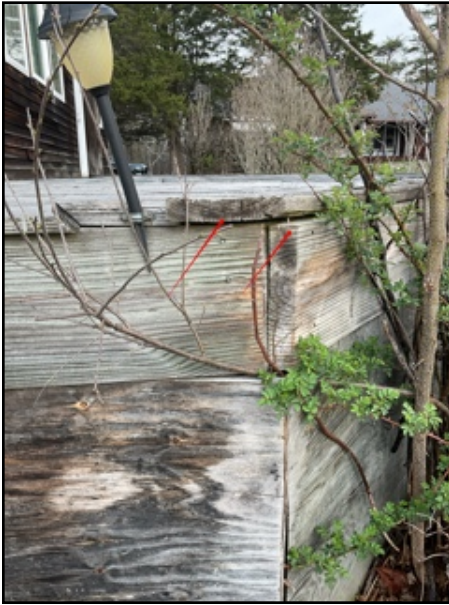
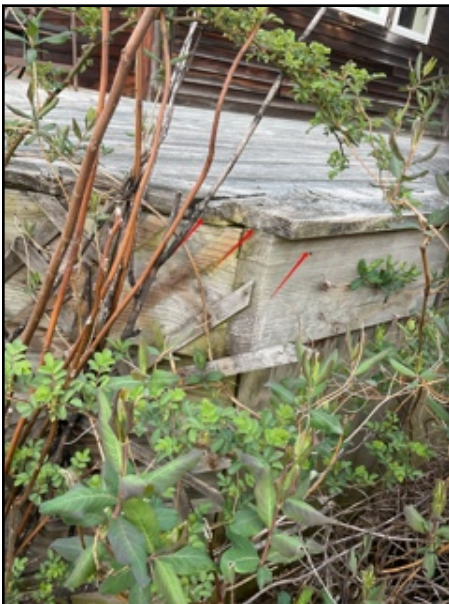
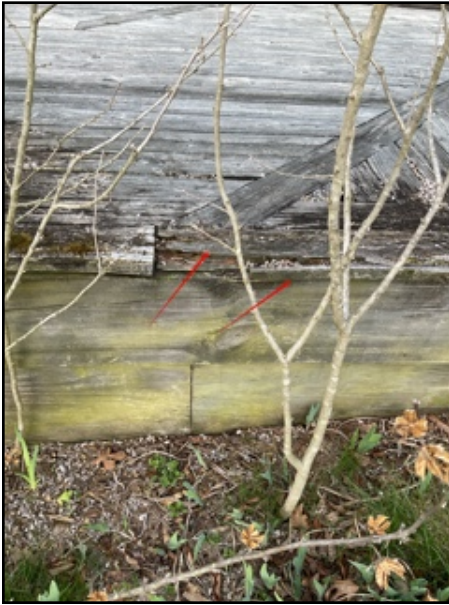
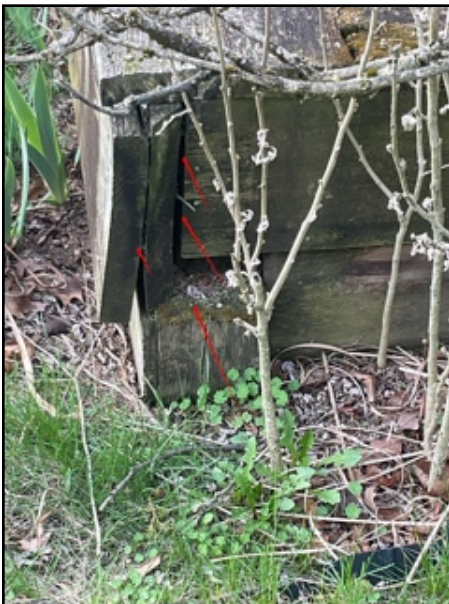
The deck has some sections that are in poor condition and some that are in marginal condition recommend repair and replace as needed for safety reasons .

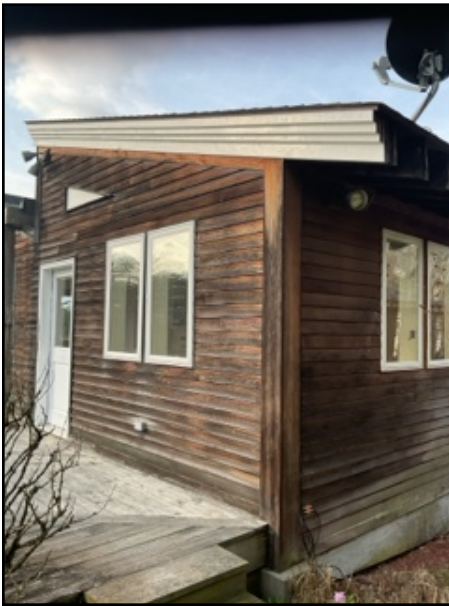
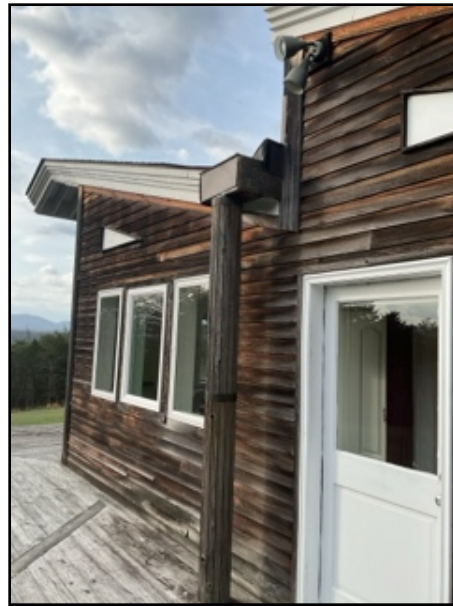
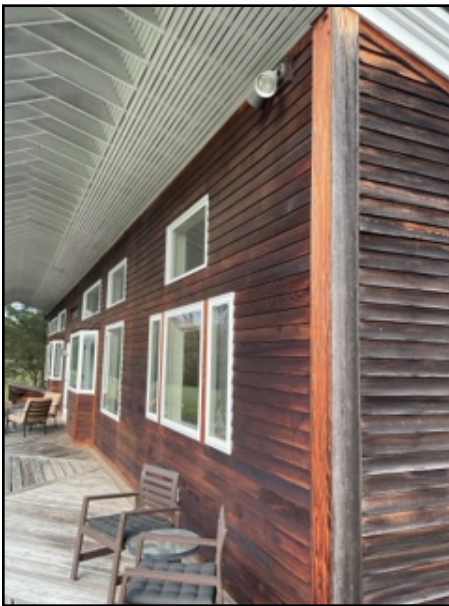
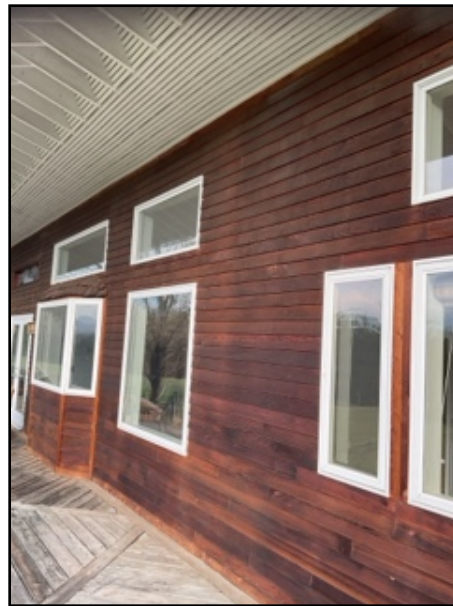
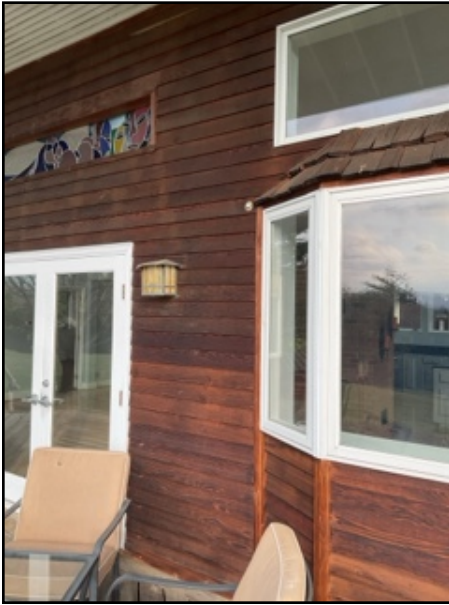
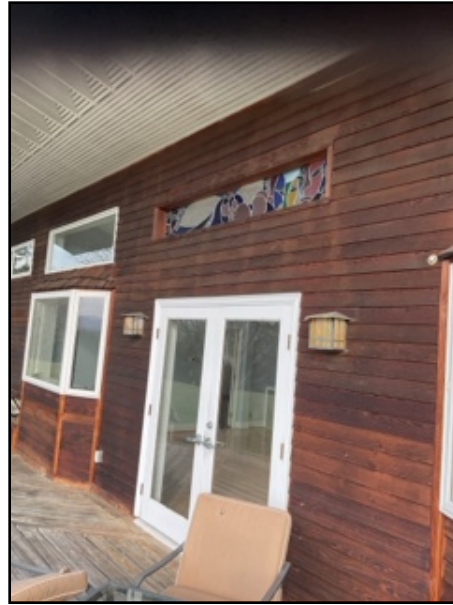
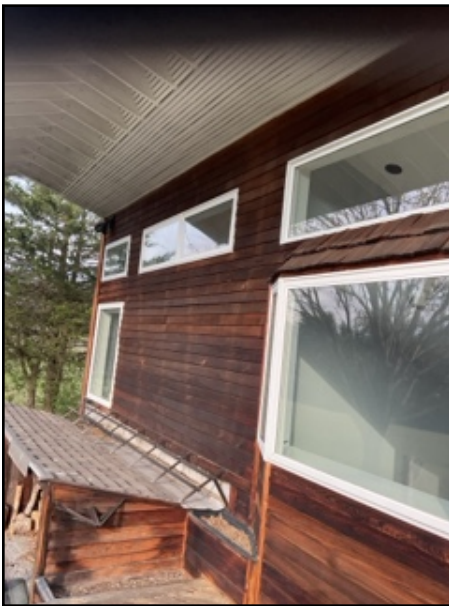
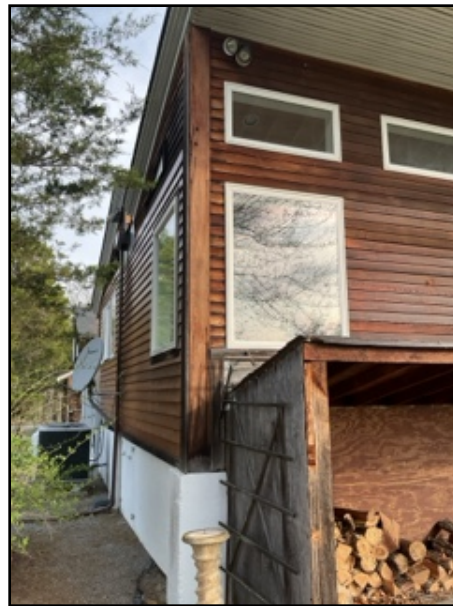
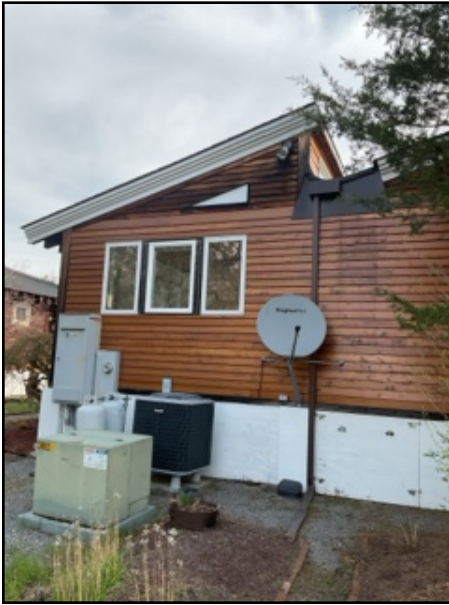
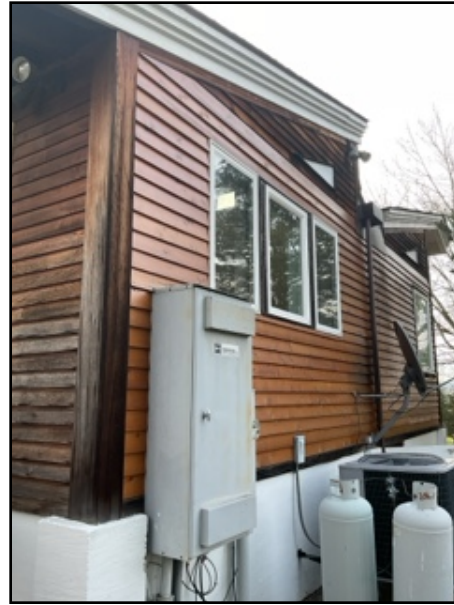
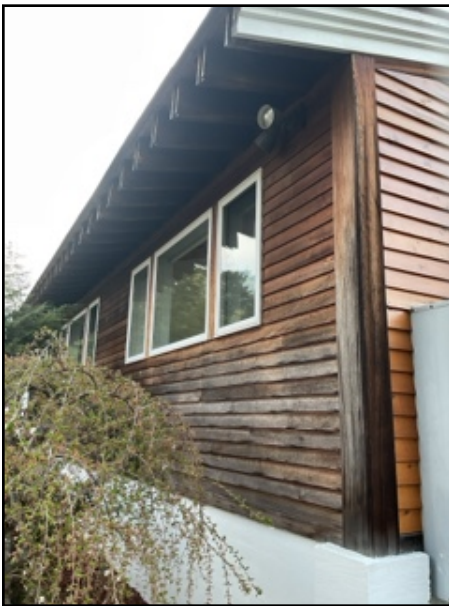
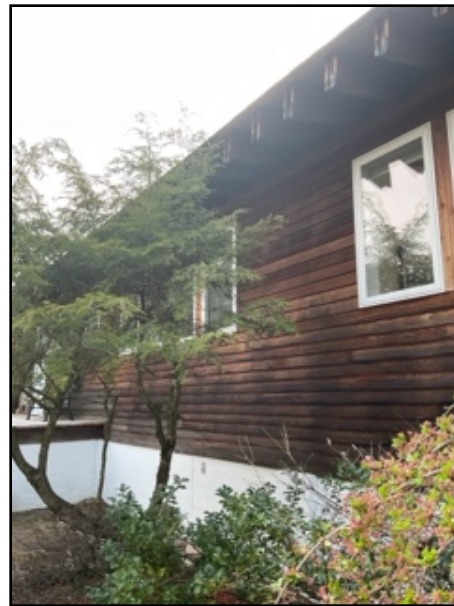
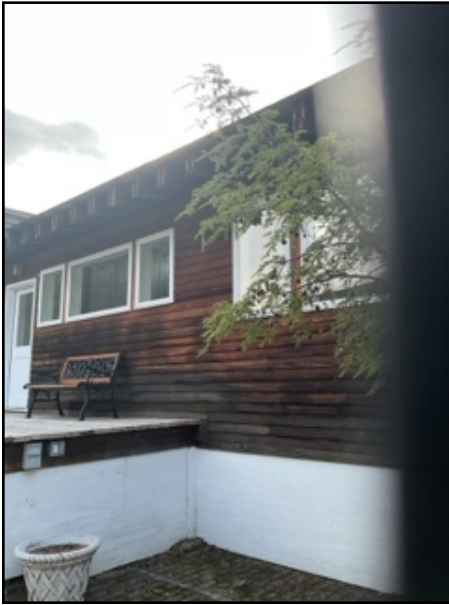
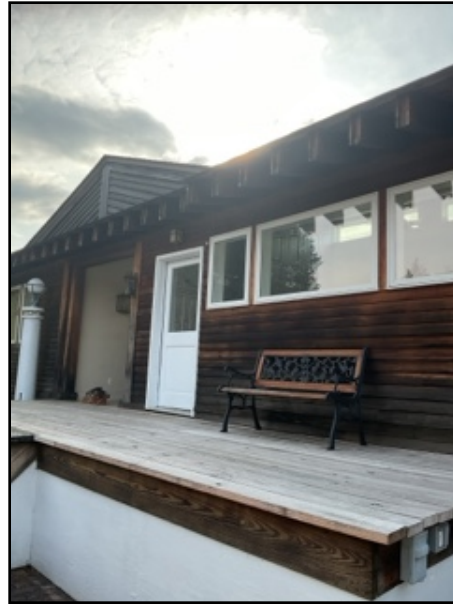
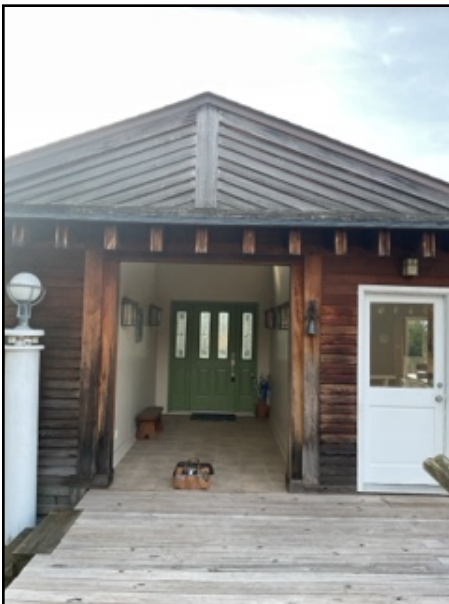
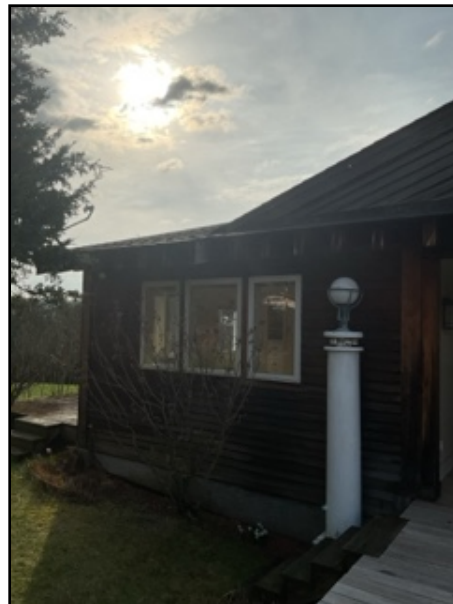
Comment 13:  
The exterior siding is satisfactory .

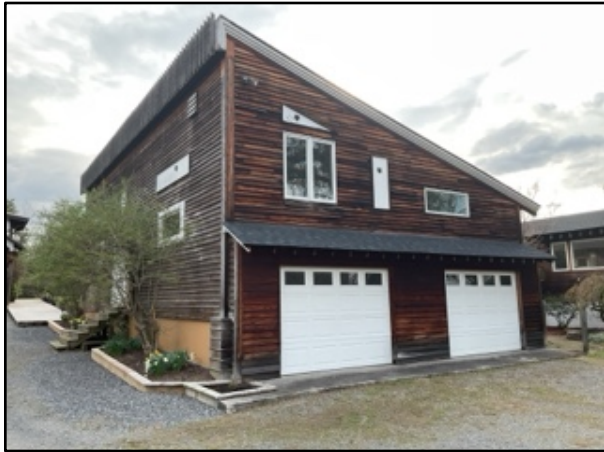
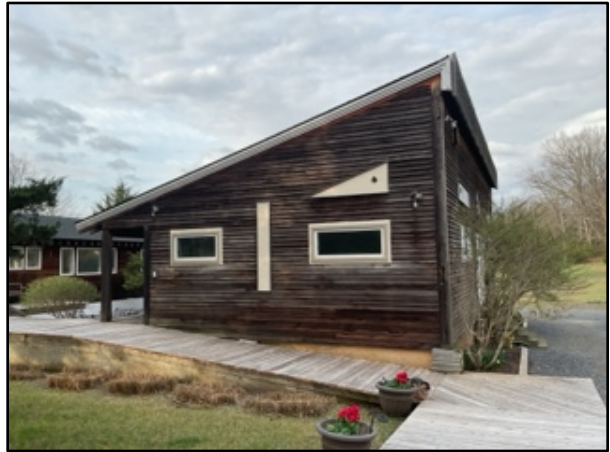
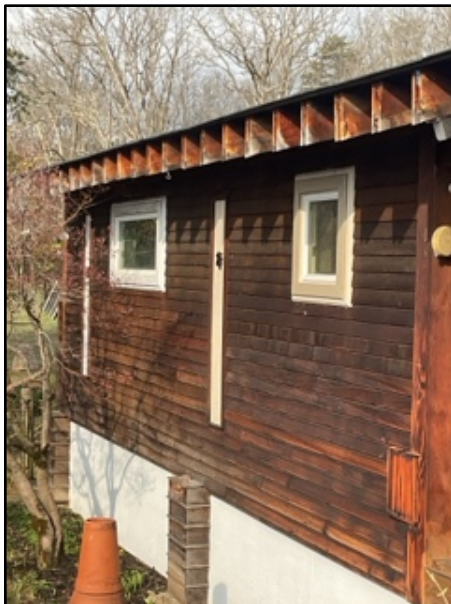
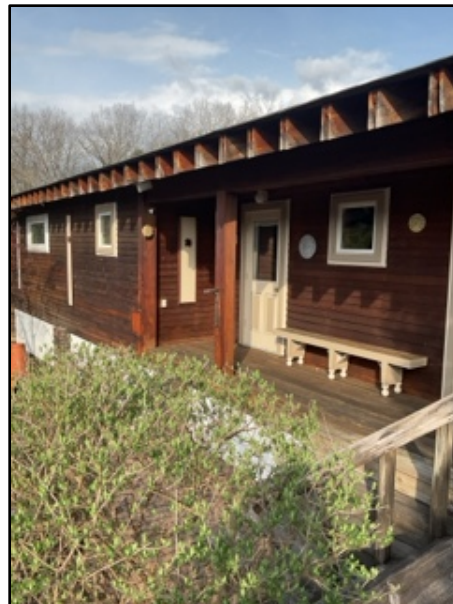
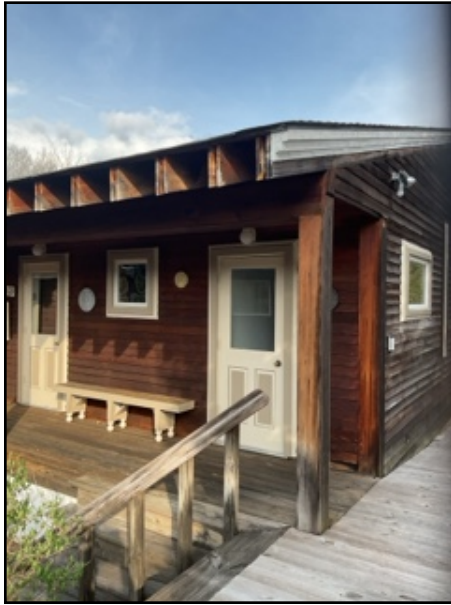
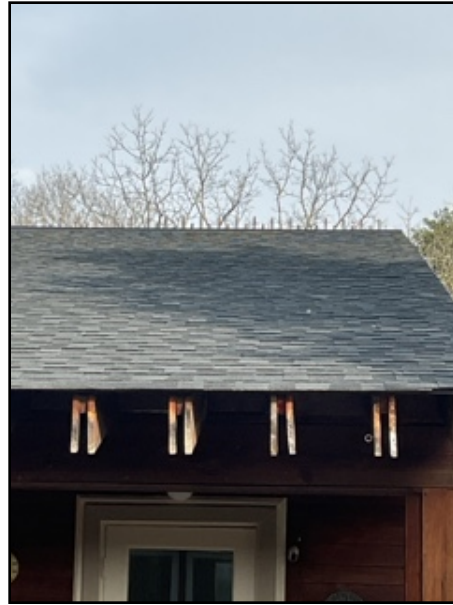
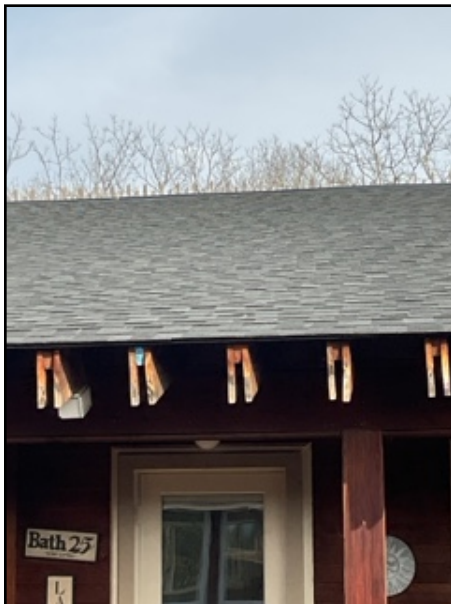
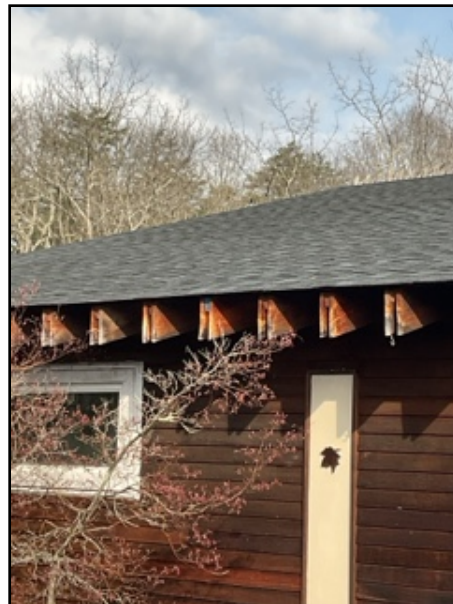
Comment 14:  
The exterior of the garage is satisfactory .

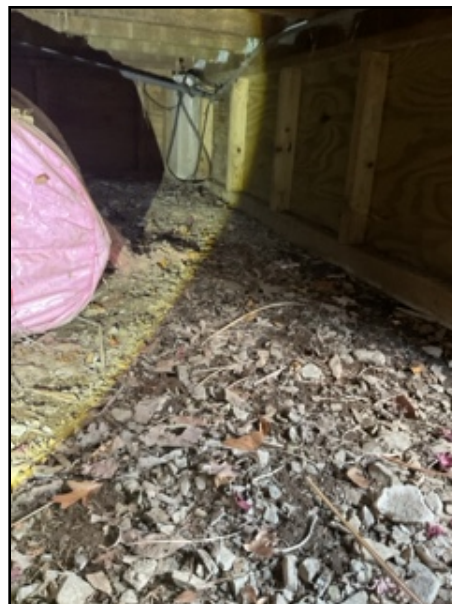
Figure 17-2

The foundation piers for the garage appear to be satisfactory if there is any doubt recommend having a licensed contractor to evaluate them for further assessment .

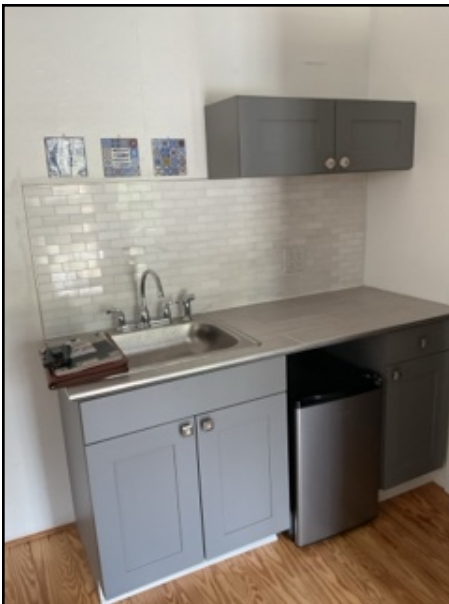
Figure 18-1

The kitchenette in the garage is satisfactory .

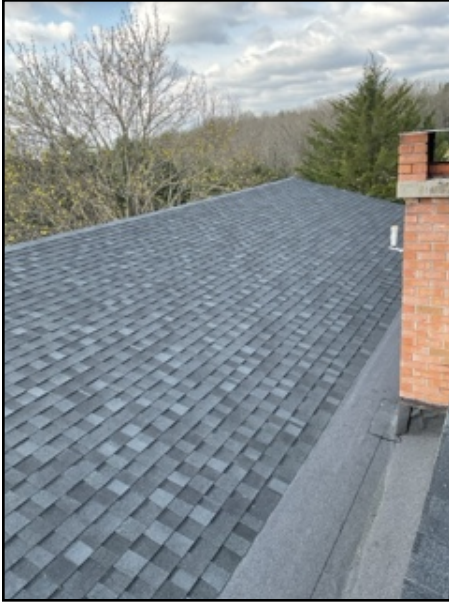
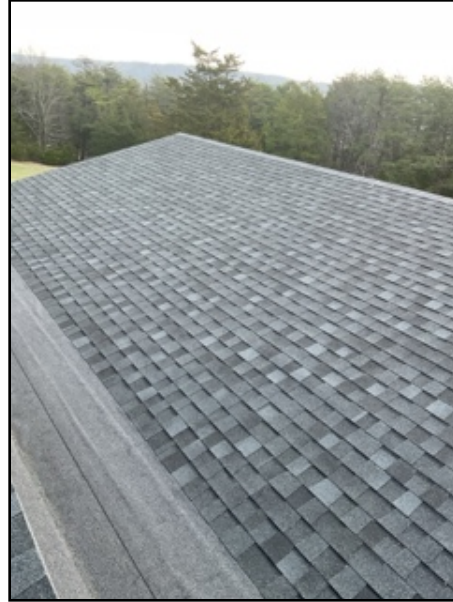
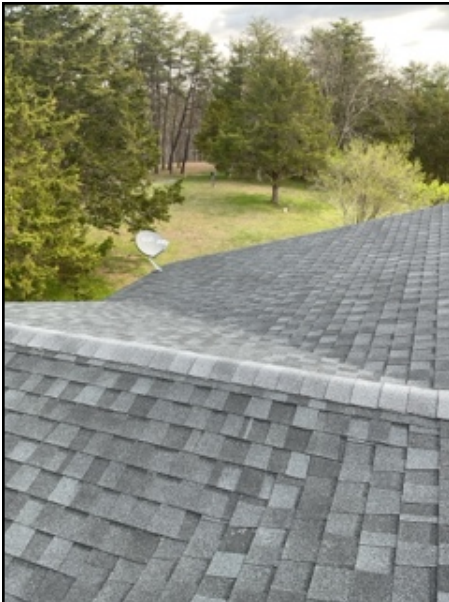
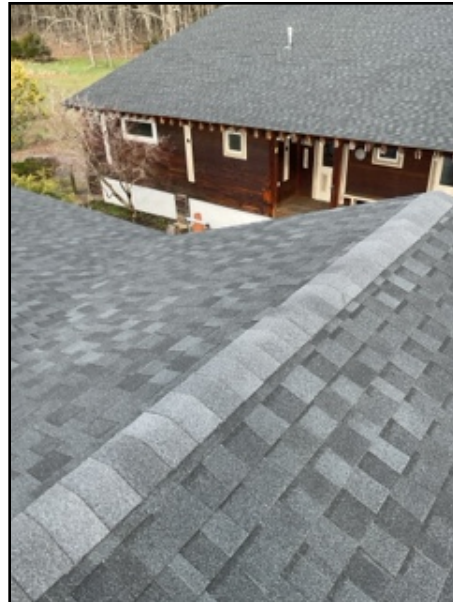
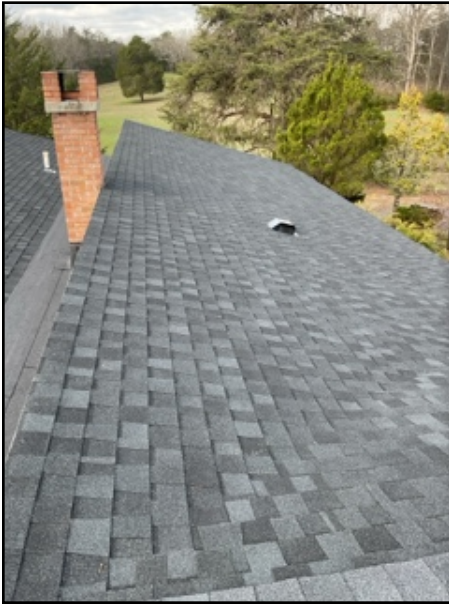
Comment 26:  
The shingles are satisfactory .

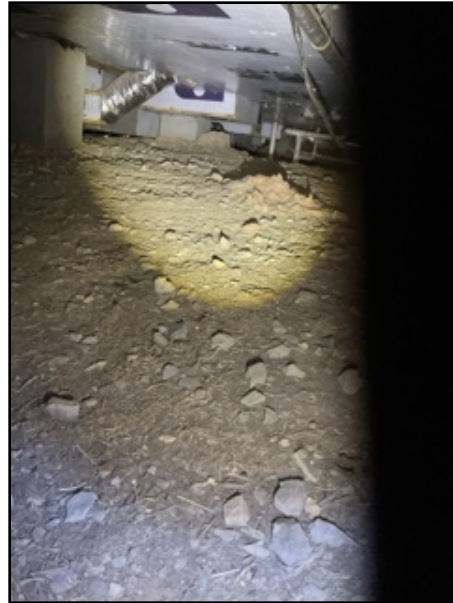
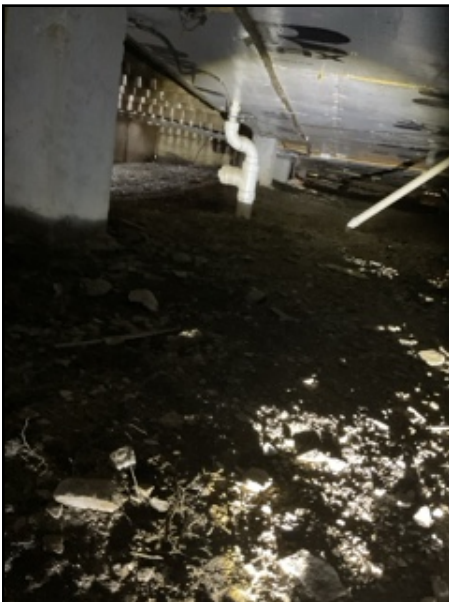
The foundation piers appear to be in satisfactory condition if there is any doubt recommend having them evaluated by a licensed contractor for further assessment

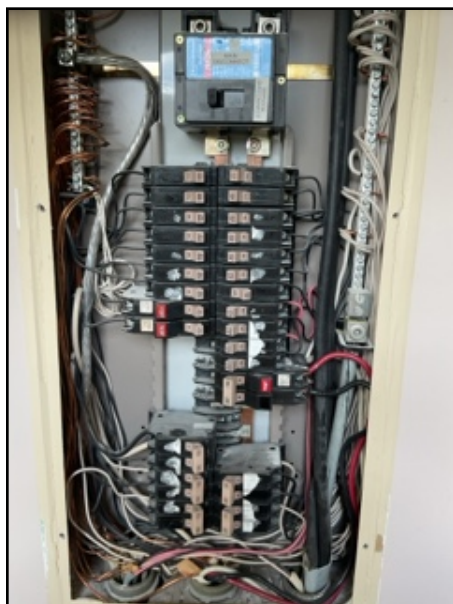
There are two 200 amp service panels and both are satisfactory .

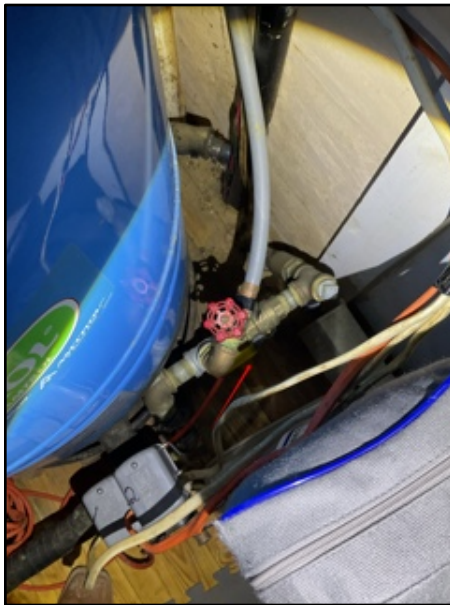
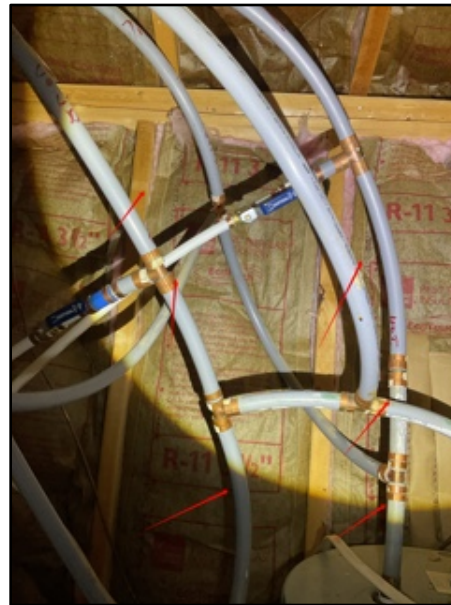
The main water shut off is located at the pressure tank in the garage apartment .

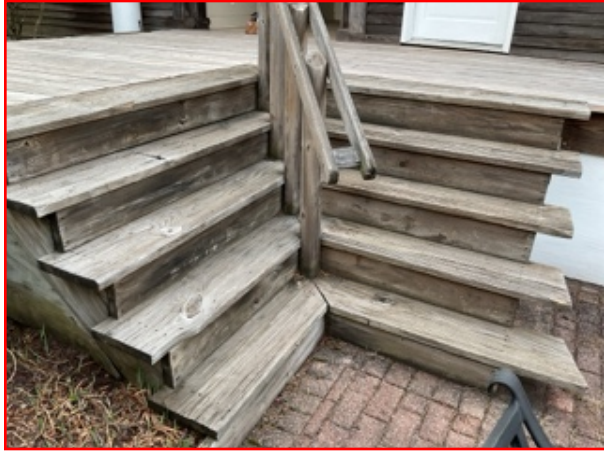
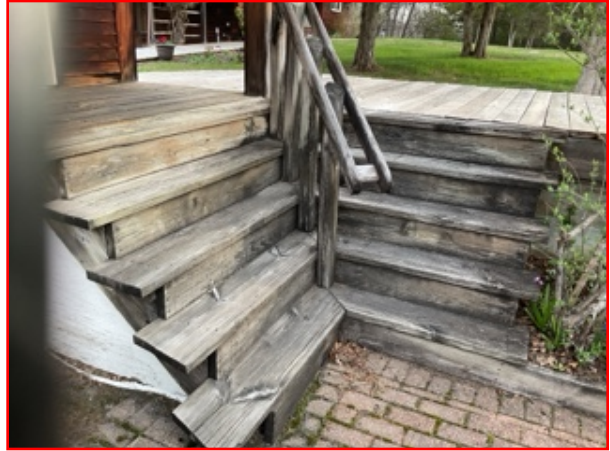
2) Some of the steps are coming loose and are in marginal condition recommend repair for safety reasons .

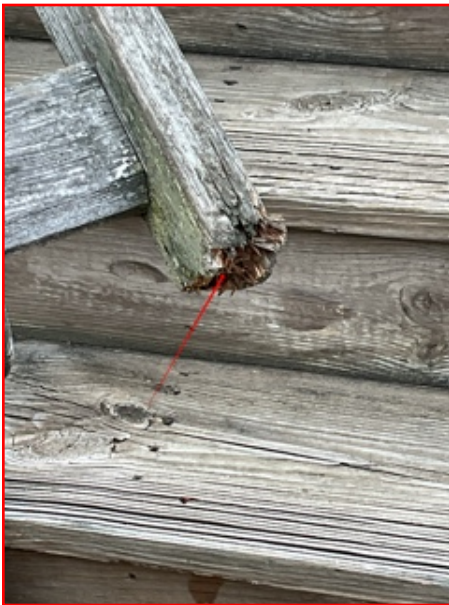
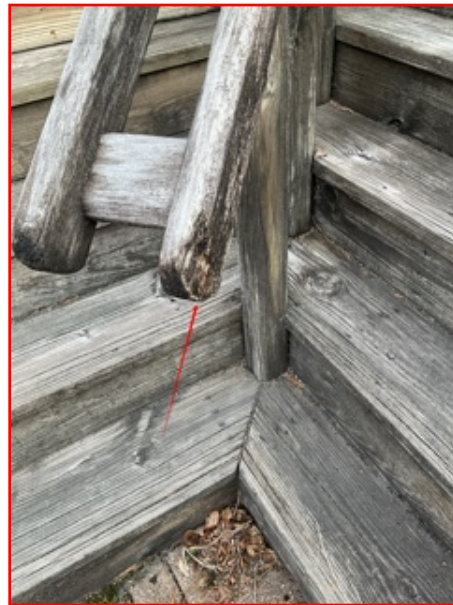
3) The hand rail is in poor condition recommend repair or replace .

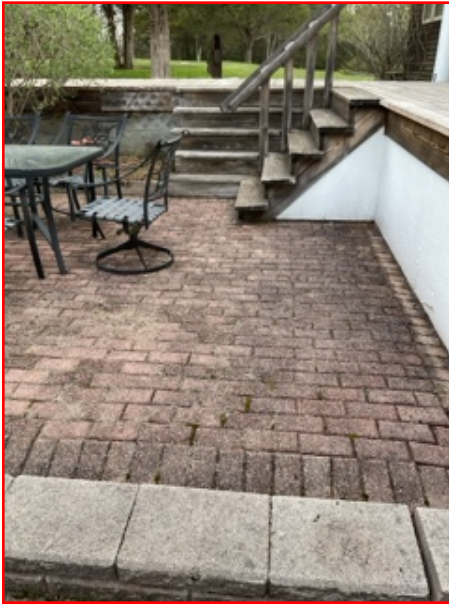
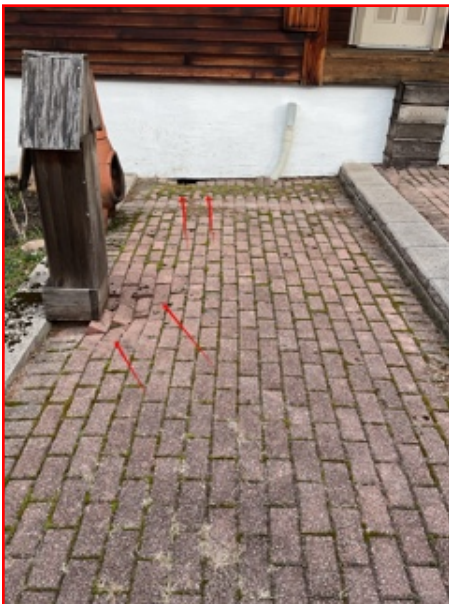
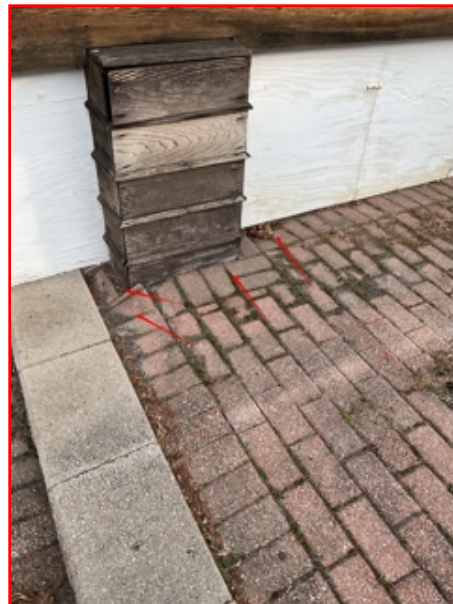
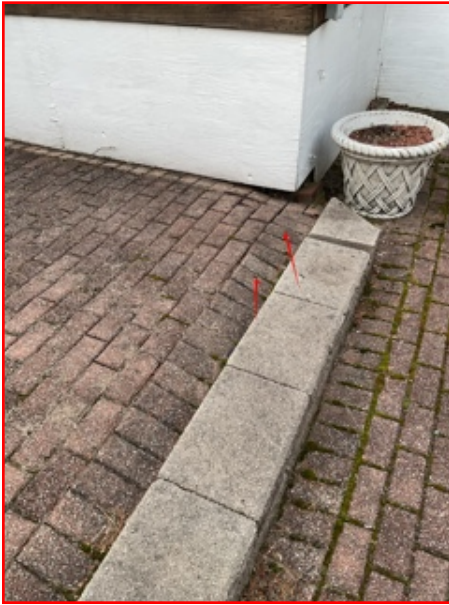
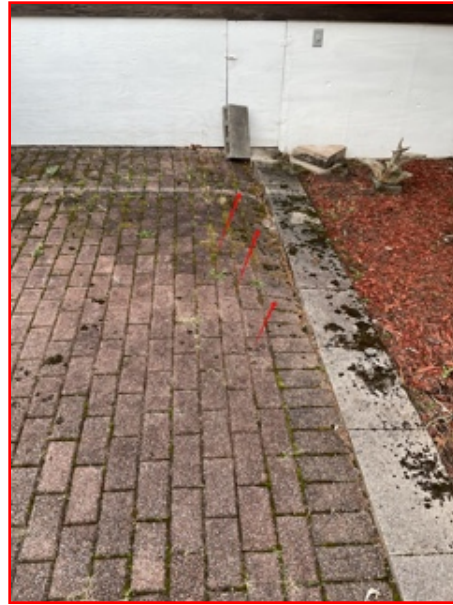
4) The patio has settled in different places causing loose pavers and tripping hazards recommend repair .

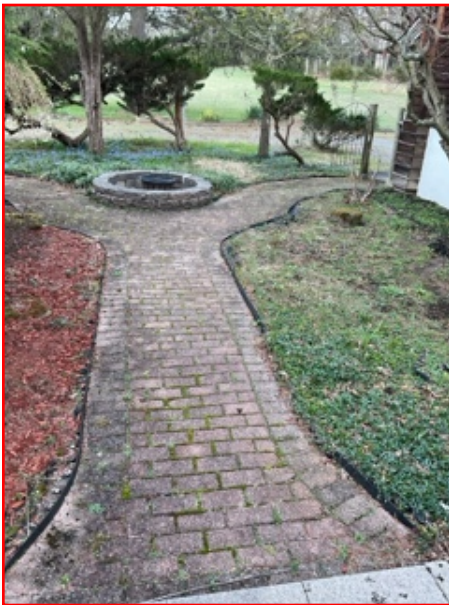
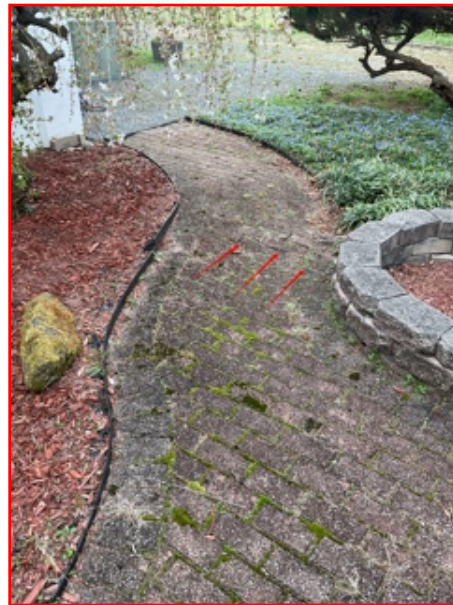
5) The paver walkway has a tripping hazard in it recommend repair .

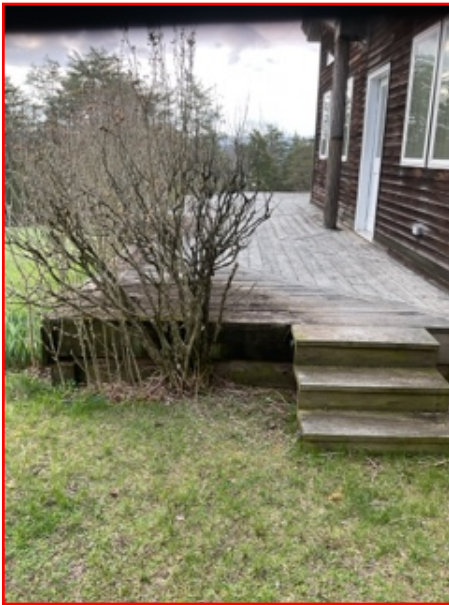
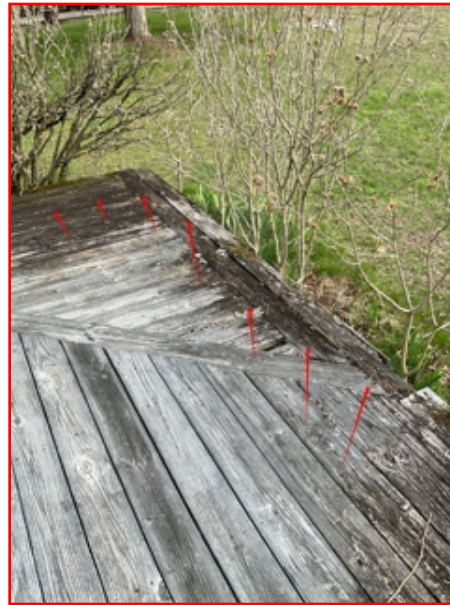
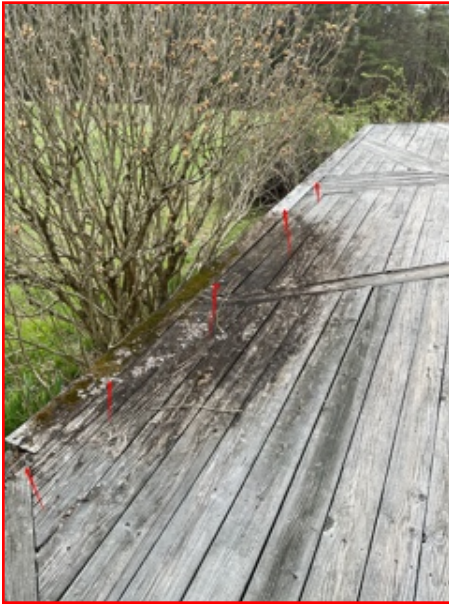
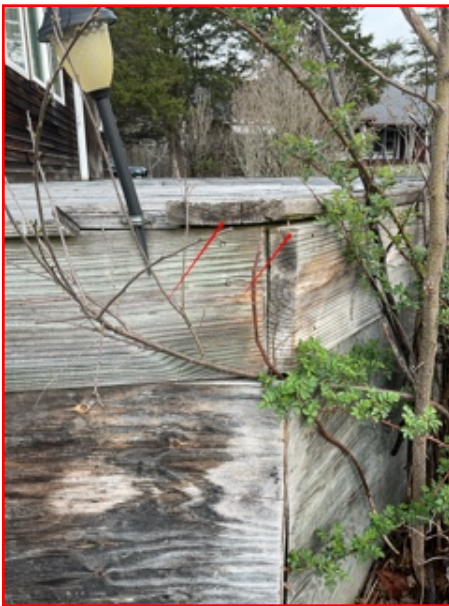
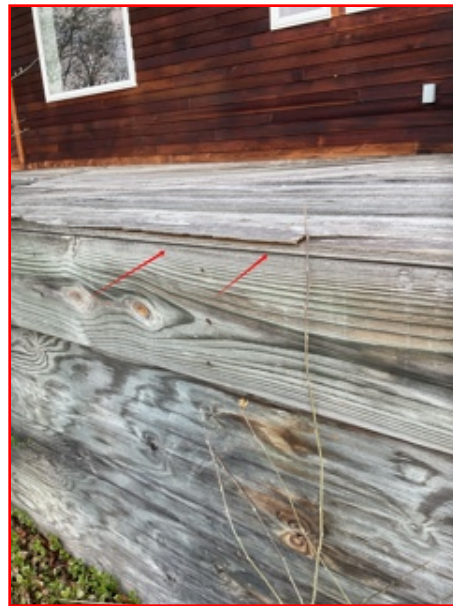
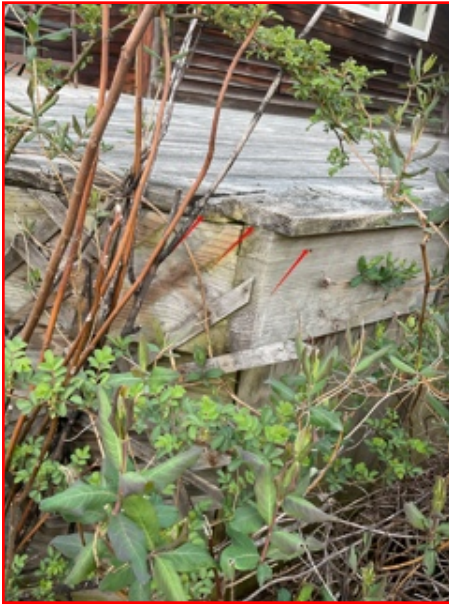
7) The deck has some sections that are in poor condition and some that are in marginal condition recommend repair and replace as needed for safety reasons .

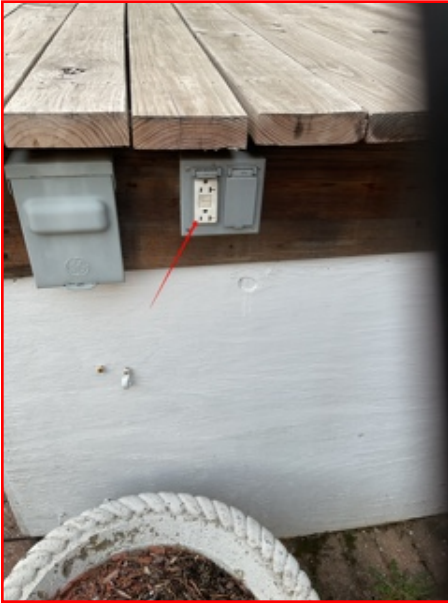
Figure 11-1

9) The front exterior receptacle attached to the porch has no power recommend repair .

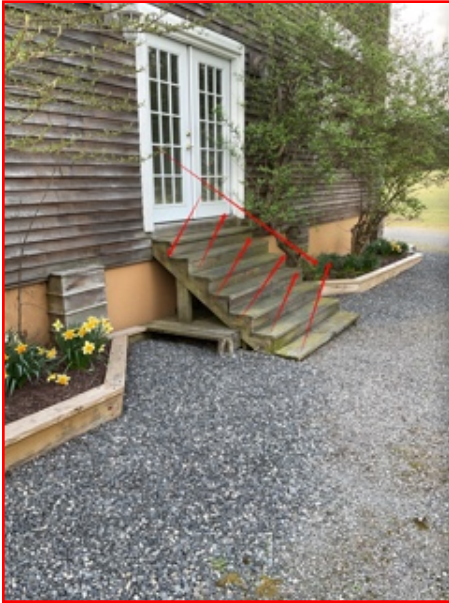
Figure 15-1

11) Recommend having a hand rail installed for safety reasons .

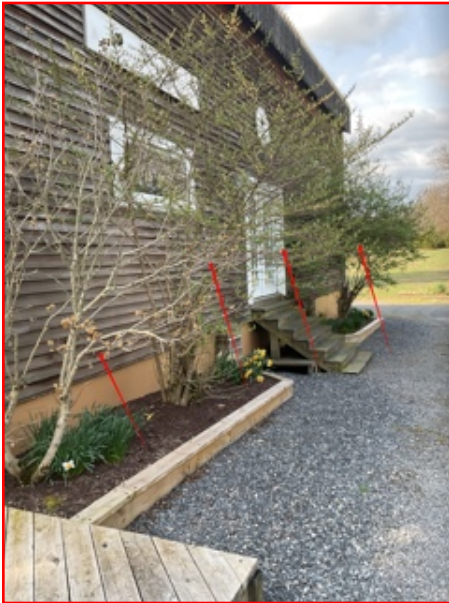
Figure 16-1

12) Recommend having the shrubs trimmed back away from the structure to prevent damage from occurring .

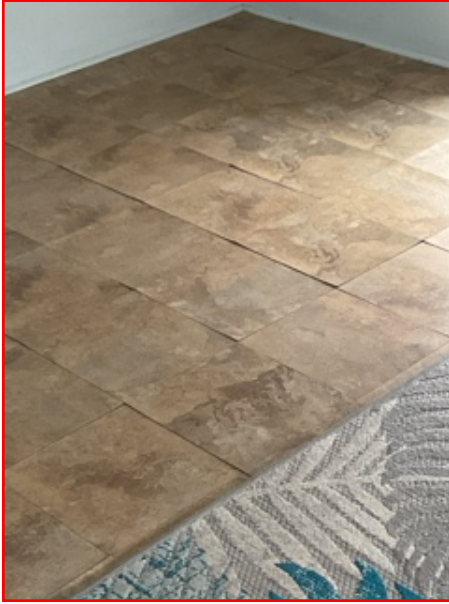
Figure 20-1

14) The vinyl flooring in the garage apartment is in poor condition recommend replacing .

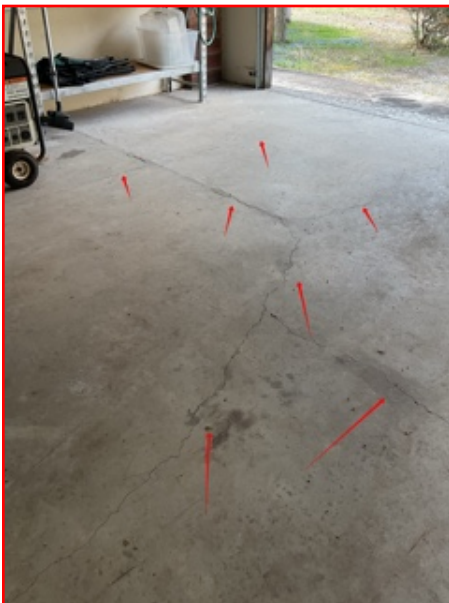
Figure 23-1

15) Recommend having the cracks in the garage floor repaired to prevent further damage from occurring .

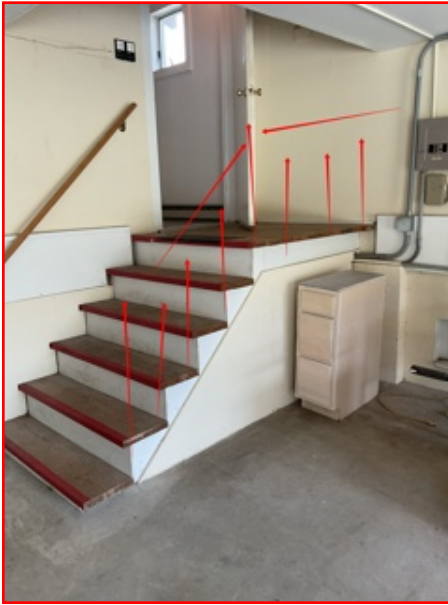
Figure 24-1

16) Recommend installing some railing for safety reason .

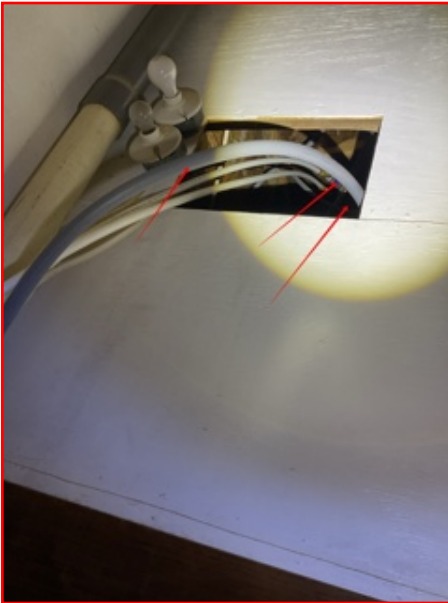
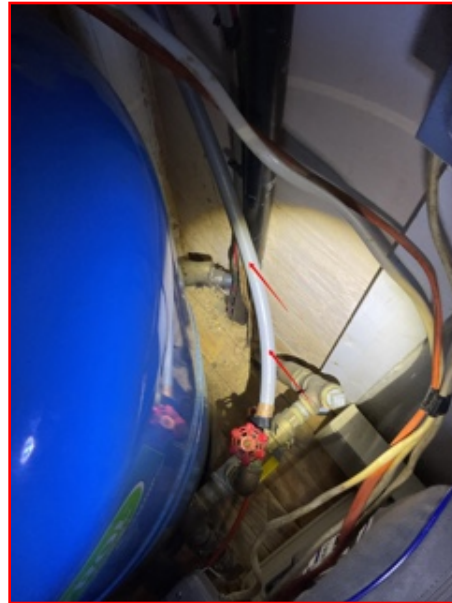
20) Some of the water supply lines are polybutylene recommend further evaluation by a licensed plumber for further assessment .

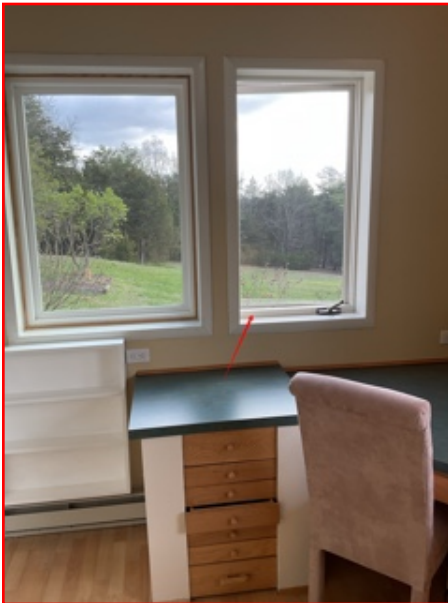
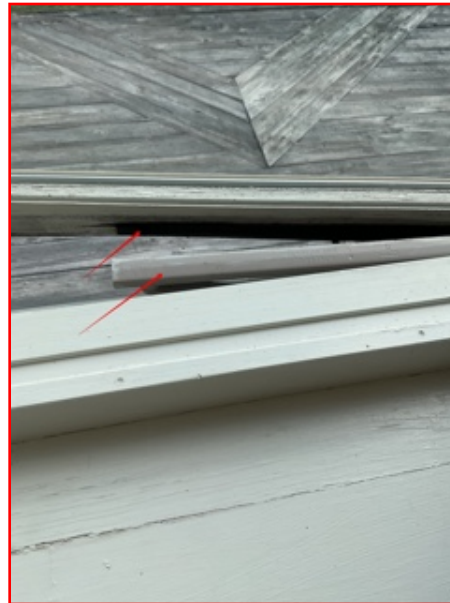
**Comment 40:**  
The left side window in the left side bedroom has come loose from its trac recommend repair .

25) The left side window in the left side bedroom has come loose from its trac recommend repair .
